University Repairs & Protects Interior Staircase With ENECRETE[®] DuraQuartz[®] & DuraFill[®]

CHEMCLAD XC “Cures” Shower Stall Problems at New Jersey Hospital

Hospital “Prescribes” CHEMCLAD SC For Pressure Tank Coating

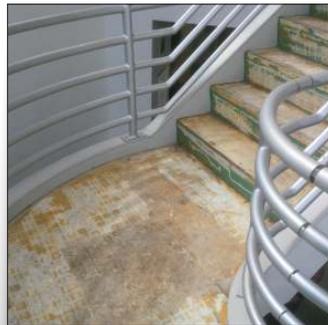
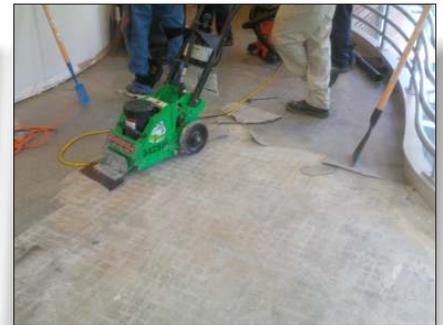
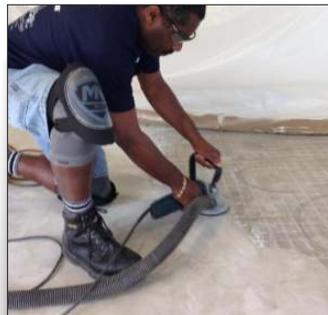
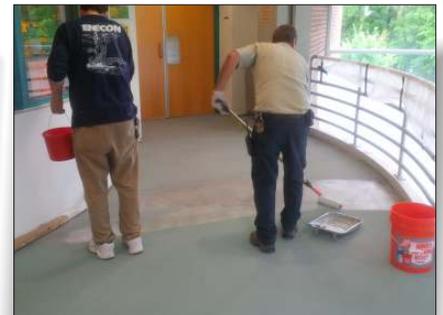
This indoor atrium staircase at a prestigious eastern U.S. university was falling into disrepair. The old vinyl tiles were detaching from the substrate causing an eyesore as well as safety concerns for students and faculty alike.

The vinyl tiles were manually removed from the staircase. The tile's

mastic was then mechanically removed from all areas and the metal step substrate was roughened.

ENECRETE DuraQuartz was used to repair any damaged areas followed by a two coat system of **ENECRETE DuraFill** with an aggregate broadcast for slip resistance in this high foot traffic area.

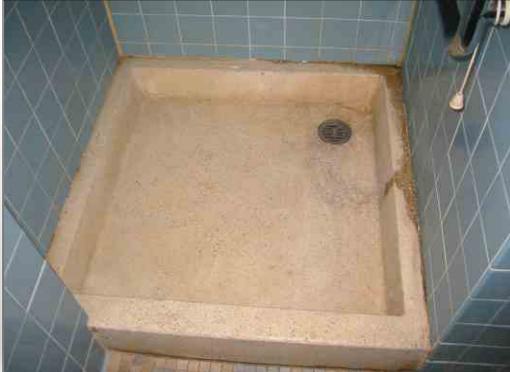
Worn, pitted basins were unsightly & impossible to clean.

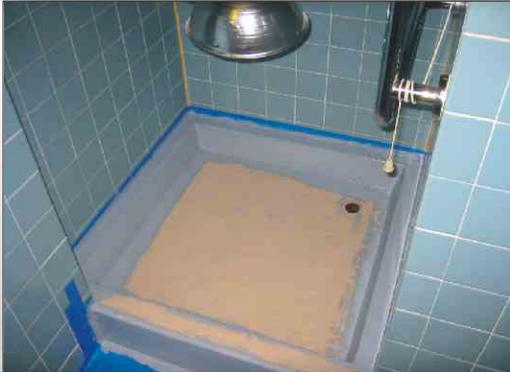
Heat lamps were used to accelerate the cure of the first layer of CHEMCLAD XC

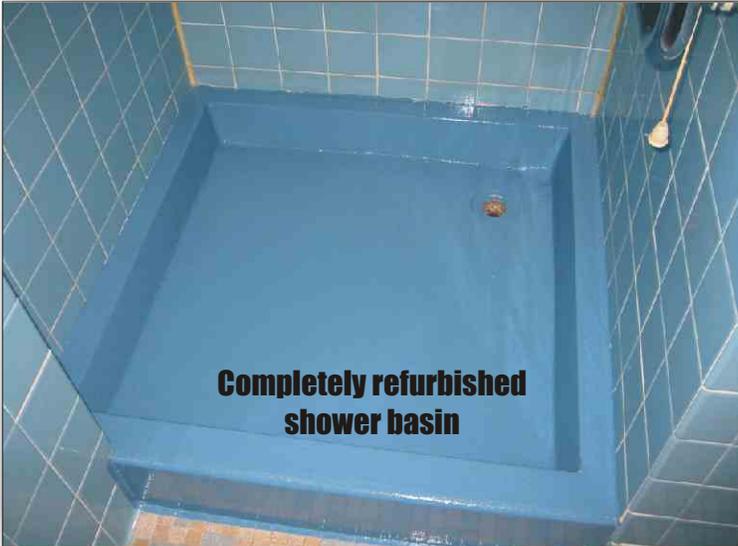
After years of constant use, the basins had become worn and pitted and the original sealer finish was gone. The basins were nearly impossible to clean and unsightly as well. Patients were reluctant to use the showers. Since occupancy is as important to a hospital as to a hotel, each shower had to be completed in one day as rooms became available.

After acid washing the basins to remove imbedded soil, soap residue and rust stains, the basins were dried using a fan.

A first layer of CHEMCLAD XC was applied by brush and roller. An anti-slip aggregate was broadcast into the uncured CHEMCLAD XC. This filled in pits in the concrete surface and improved the safety of the showers. After sweeping up the excess aggregate, a second layer of CHEMCLAD XC in the finished color was applied.

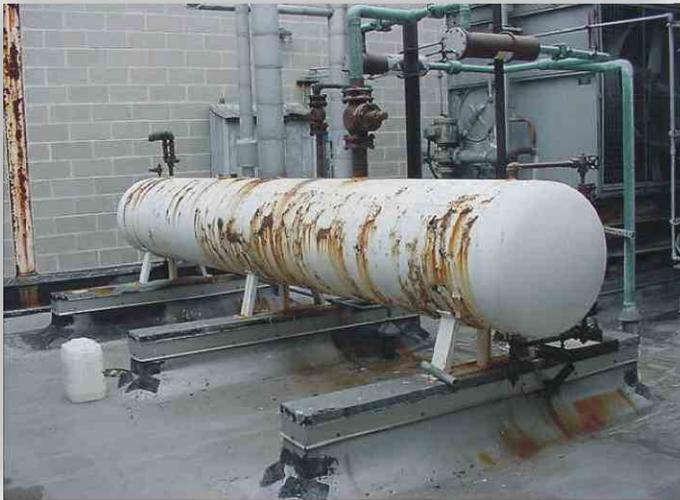
Badly rusted pressure tank and support legs. Project called for grit blasting tank and supports, then treating with CHEMCLAD SC (2 coats).

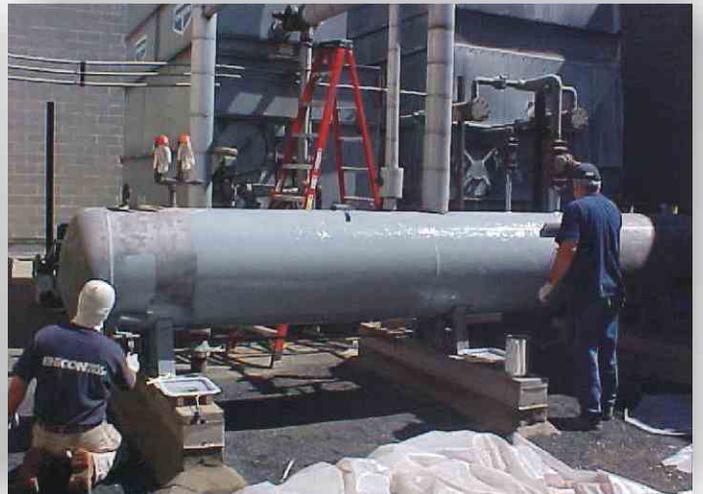
First coat of CHEMCLAD SC being roller-applied to tank and support surfaces.

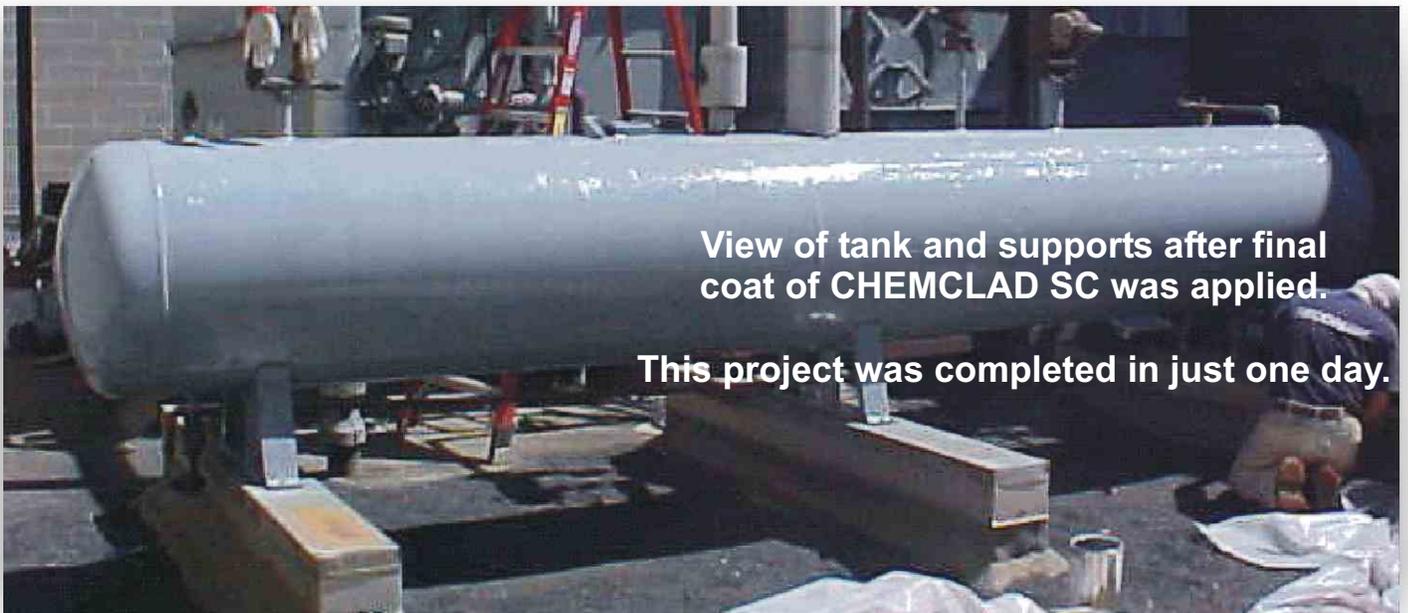
View of tank and supports after final coat of CHEMCLAD SC was applied.

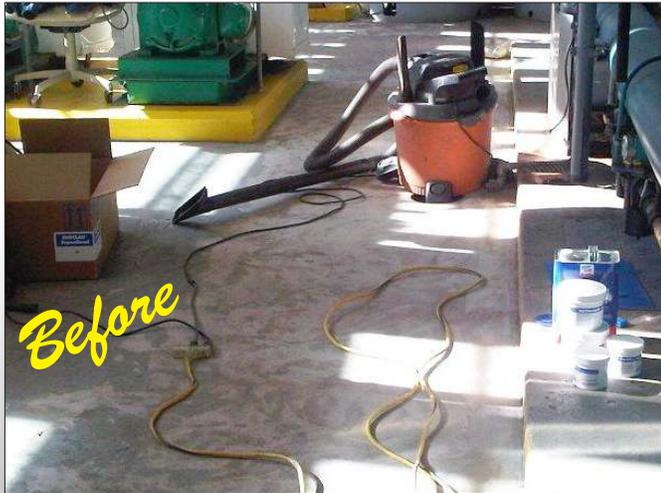
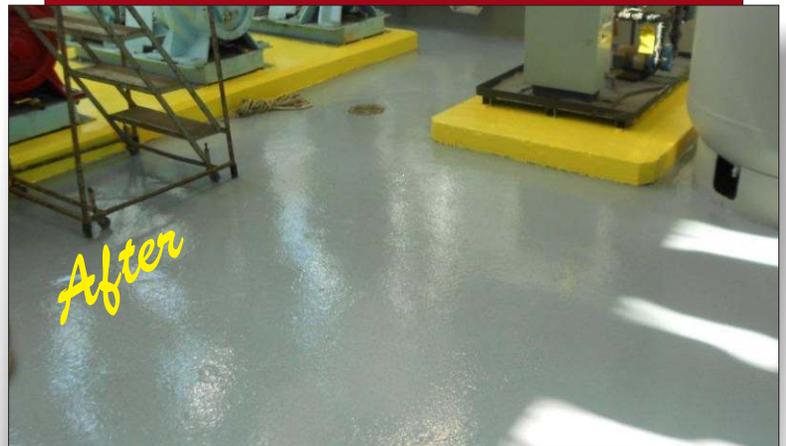
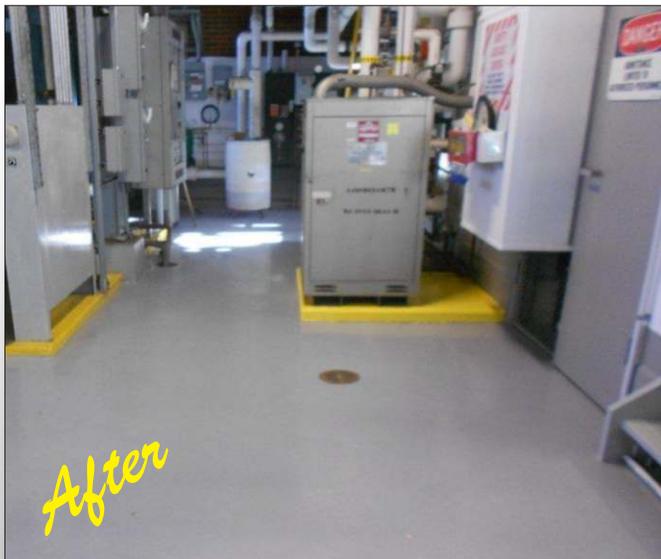
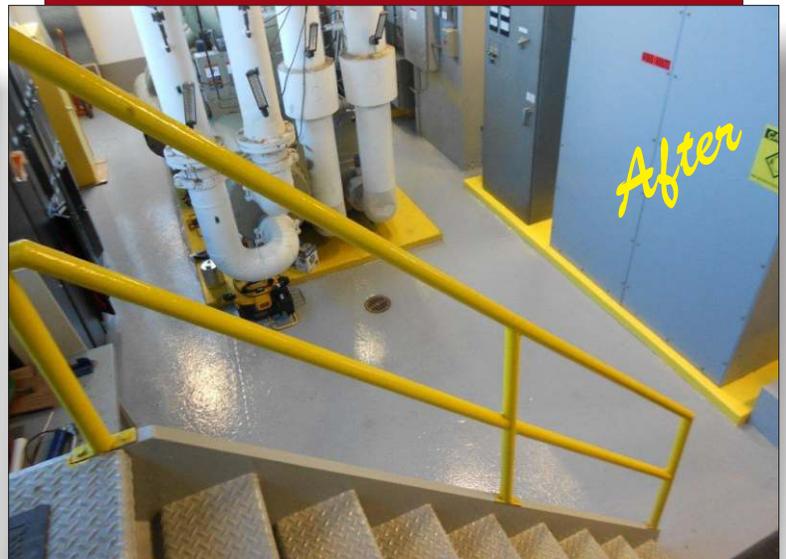
Problem: The original coating on this 2900 sq. ft. mechanical room floor was flaking and chipping. The concrete had also begun to crack and spall in several areas.

Solution: Any damaged areas were manually prepared, then repaired with ENECRETE DuraQuartz. Areas where the original coating was failing were scraped and cleaned with solvent where necessary. The entire floor was then abraded. ENECLAD SuperBond was applied to provide optimum adhesion. Finally, CHEMCLAD SC was applied with broadcast glass bead aggregate and then back-rolled to provide a slip-resistant surface.

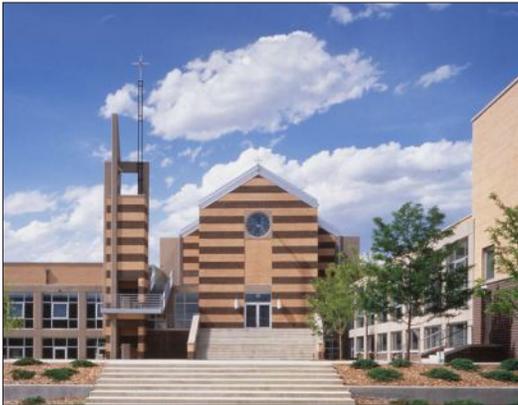
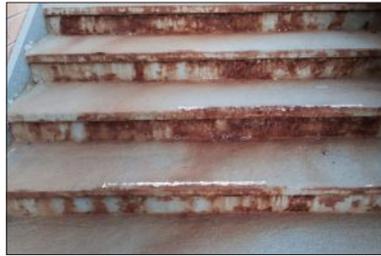
Problem: High traffic staircases were suffering from corroded steel tread nosings and damaged concrete treads. This caused both unsafe conditions for students, faculty and visitors as well as being very unsightly.

Solution: The stairs were manually prepared by abrasive blasting the steel nosings and concrete treads to remove any corrosion and old, failed coating systems. The nosings were given a first coat of CHEMCLAD SC and the concrete was primed with CHEMCLAD P4C. DurAlloy was then used to fill in any pitted areas. A top coat of CHEMCLAD SC Tan was applied and white aluminum oxide was back-rolled to provide slip-resistance. Finally, the staircase steel frames were cleaned and ENESEAL CR was applied to provide corrosion resistance.

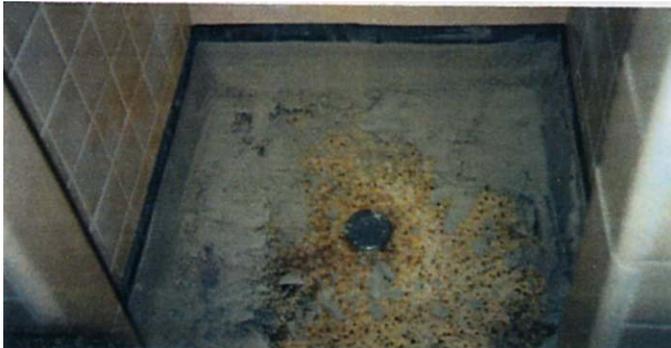
Leaking existing terrazzo shower pan. Note tape applied above the first course of tiles to neatly define the DuraQuartz repair.

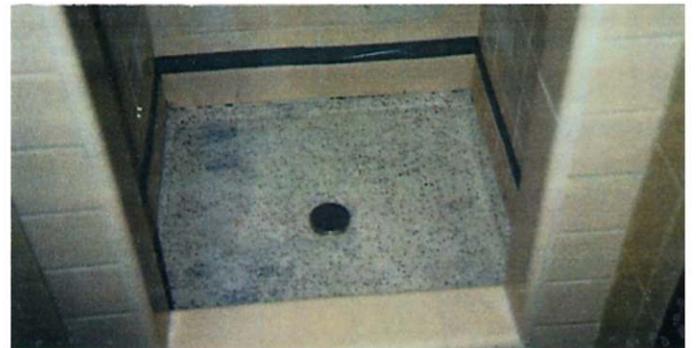
After all the surfaces to be protected are primed, the ENECRETE DuraQuartz application begins.

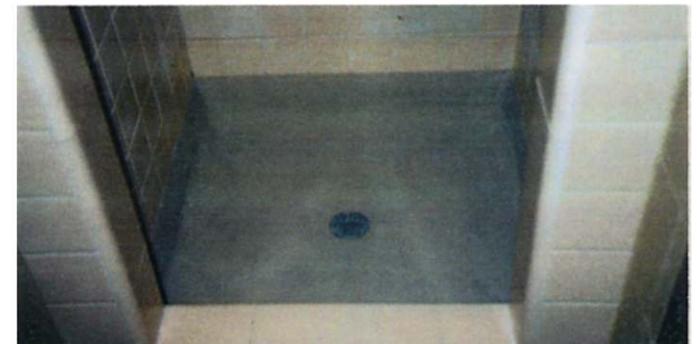
The existing shower stall beautifully finished with DuraQuartz.

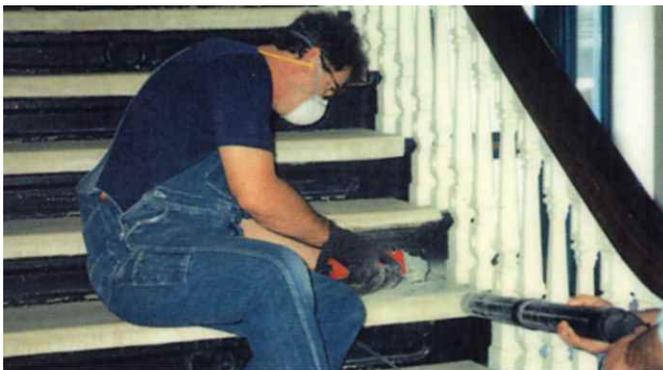
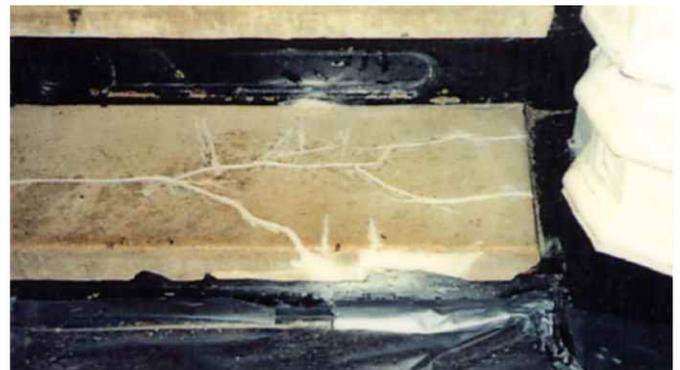
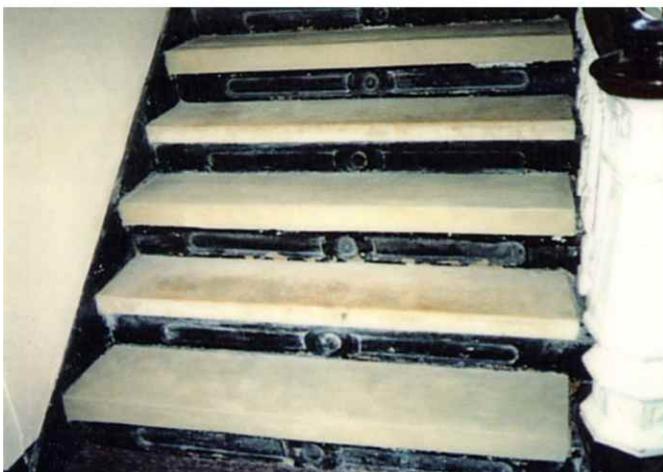
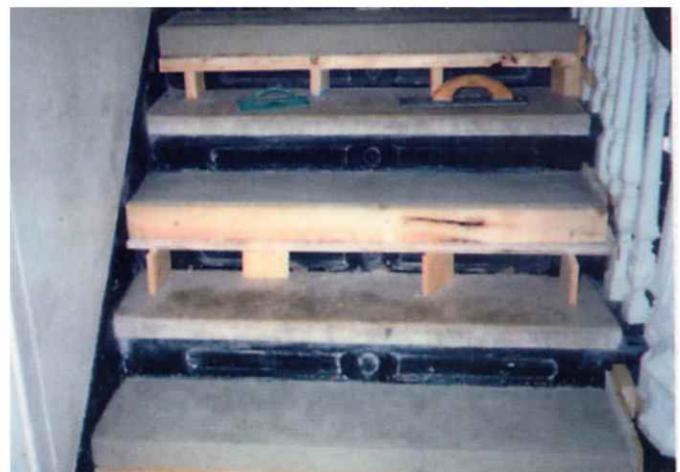
The Superintendent of Buildings & Grounds at the school was very concerned about the potential problems that conventional patching materials would have in adhering to the very old stone steps. He knew that

Supervising the institution's own, highly competent maintenance crew, The ENECON Engineer insured that all the cracks in the stonework were first repaired with the DuraQuartz and then a quarter-inch topping of DuraQuartz was applied over all the step surfaces.

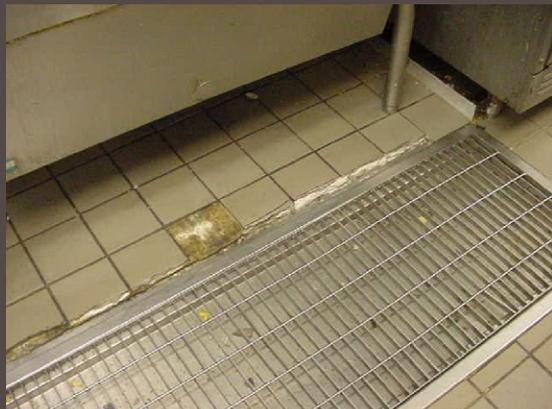
Portions of tiles where grout had failed were chipped away.

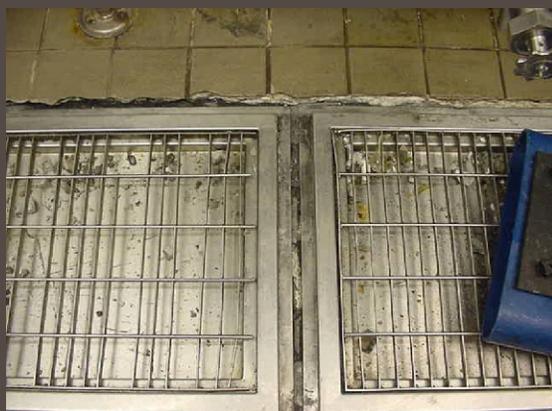
Some tiles were in such poor shape that they were completely removed.

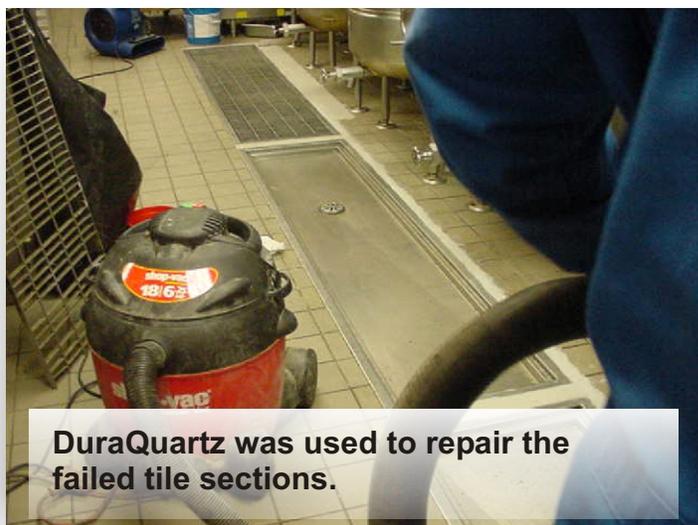
DuraQuartz was used to repair the failed tile sections.

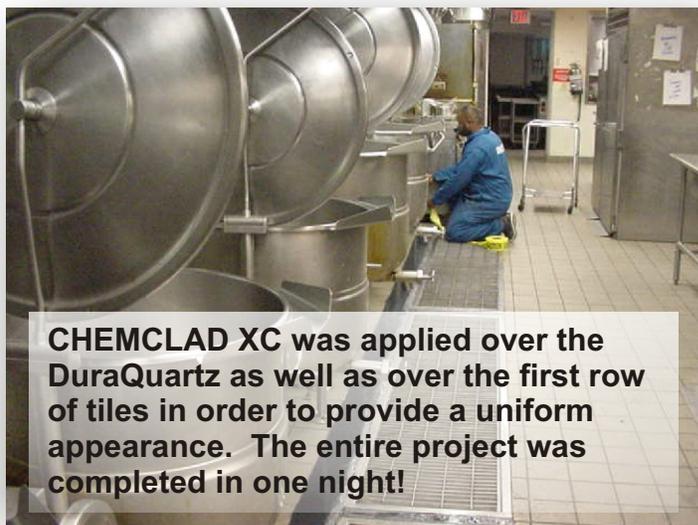
CHEMCLAD XC was applied over the DuraQuartz as well as over the first row of tiles in order to provide a uniform appearance. The entire project was completed in one night!

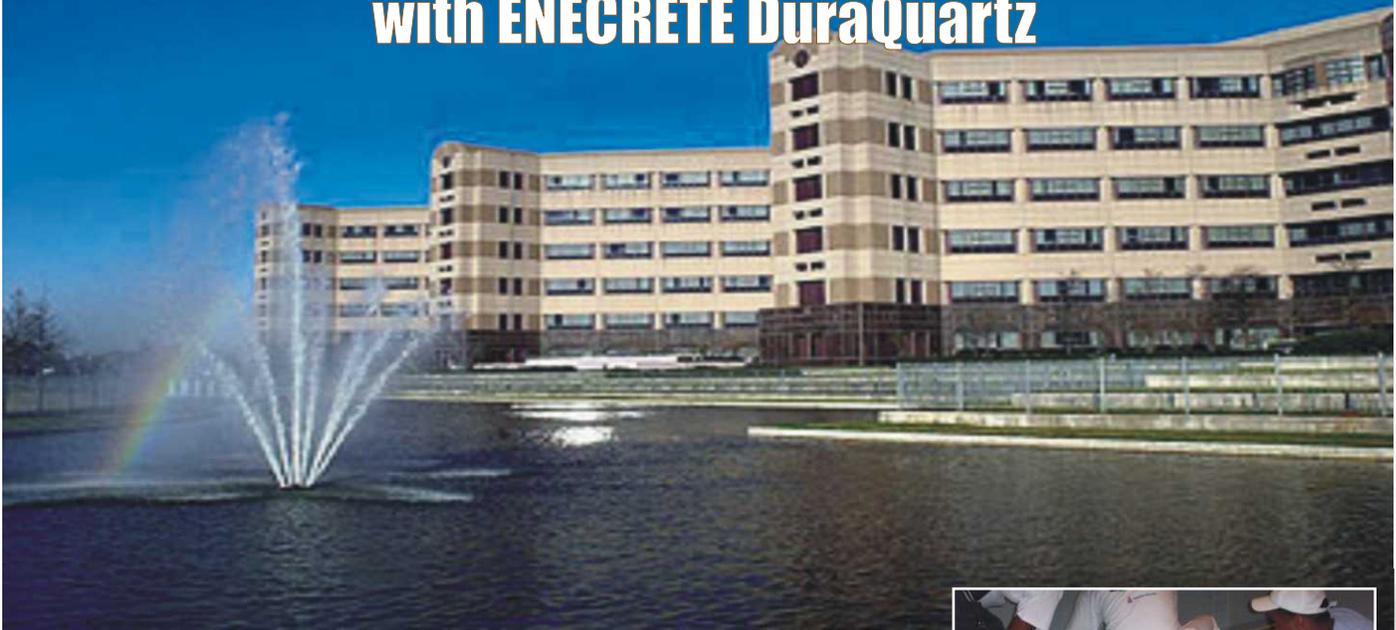
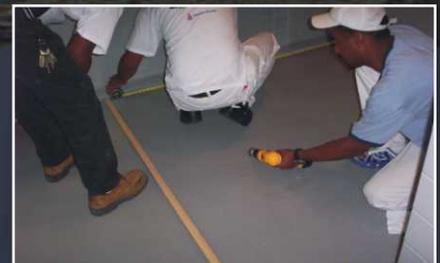
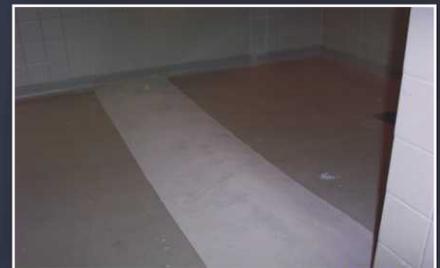
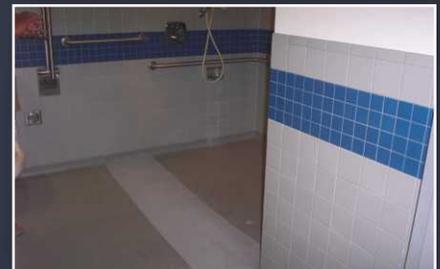
This large Veteran's Hospital in Texas had a slipping problem in some of their bathrooms. Water from the shower areas would run into the bathrooms creating slip hazards near the sinks and stalls. They needed a way to contain the water in the showers

containment burms (bumps) to keep the water from spilling into the bathroom areas. These burms are about 20 inches wide and about 2 inches high at the center. They were tapered to a "feather-edge" in order to permit wheelchairs to be easily rolled over them.

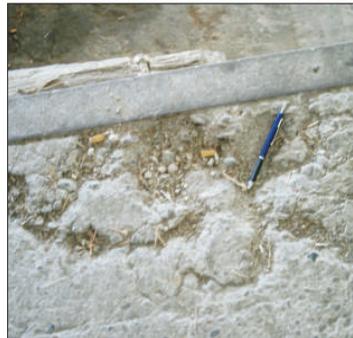
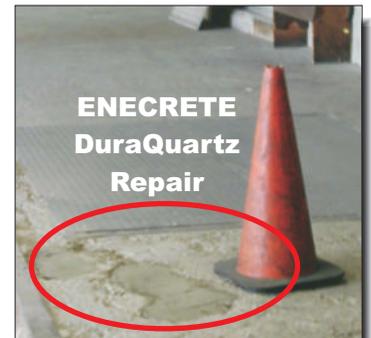
The condition of this busy loading dock was a safety concern to the maintenance engineers of a Philadelphia school district.

The local ENECON Field Engineering Specialist was consulted and it was recommended the holes on the loading dock first be repaired and leveled with DuraQuartz.

After the holes were successfully repaired, one coat of DuraFill was applied along with a single broadcast of a quartz and sand mixture. The final coat of DuraFill was then applied.

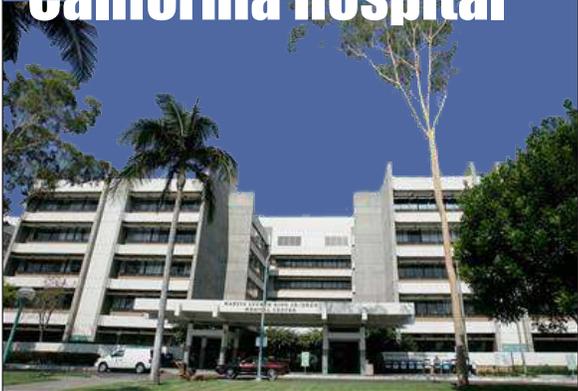
Maintenance engineers at this county hospital in Southern California were looking for a fast and cost effective method to repair and protect concrete salt pits that were suffering from severe corrosion.

The local ENECON Field Engineering Specialist was contacted and he recommended rebuilding the damaged concrete edges with **DuraQuartz** and then protecting them with **CHEMCLAD GP** to prevent further corrosion damage.

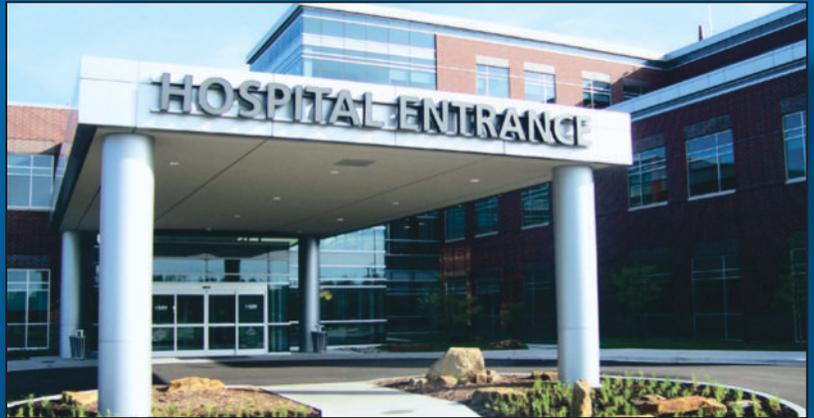
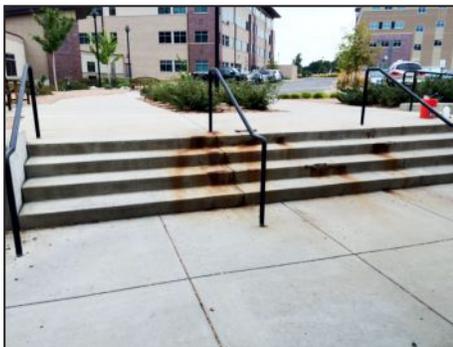
After only 12 years in use this staircase was cracked, crumbling and badly stained from the harsh elements and routine de-icing efforts during the harsh Colorado winters.

Stair noses were broken on several stairs and there were multiple areas of missing concrete.

The stairs were first cleaned with lemon juice to remove the staining. Then DuraQuartz was used to repair the stair noses and voids in the concrete. Seams and expansion joints were taped and three coats of a Durafill broadcast system were rolled out.

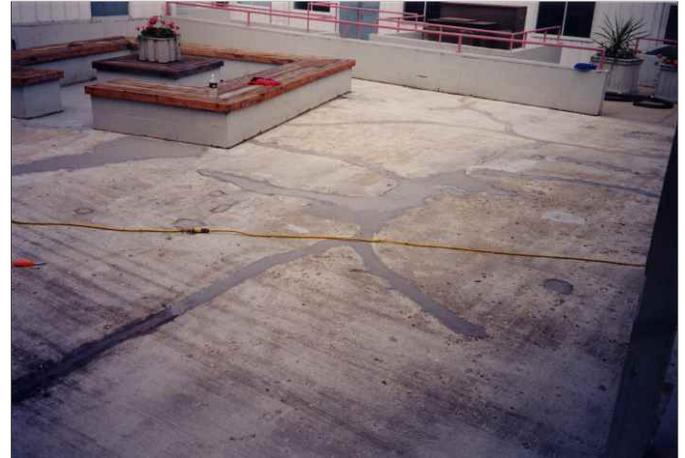
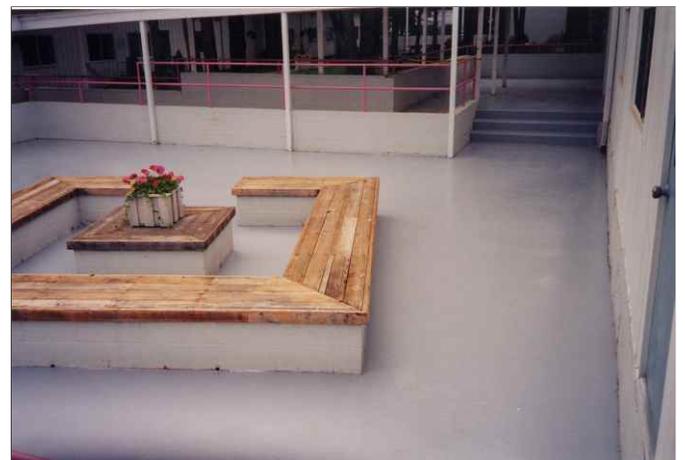
The application shown here is typical of the outstanding results that can be achieved with ENECLAD systems: A local school on Long Island had an extreme problem with its center plaza courtyard. The concrete was broken, cracked and severely spalled as seen here.

engineer to repair and protect the concrete plaza. Larger cracks were first repaired with **ENECRETE DuraQuartz** and then **ENECLAD Self Priming Screed** was applied to level the damaged concrete slab and fill in any hair-line cracks.

ENECLAD FPS was then applied to provide a seamless, highly durable floor. Non-skid aggregates were incorporated into the FPS to provide for a safety non-slip surface in this outdoor area.

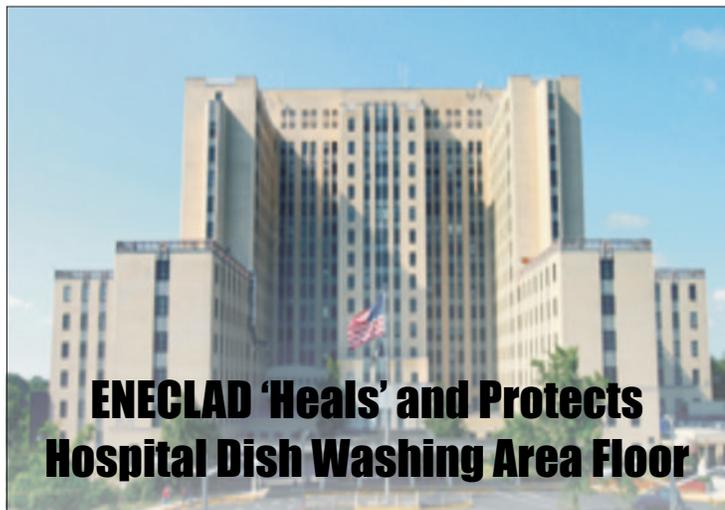
This tile floor located inside a New Jersey hospital's dish washing area had begun to deteriorate. Grout was wearing away, missing or had become porous allowing leaks from spilled water into the floor below.

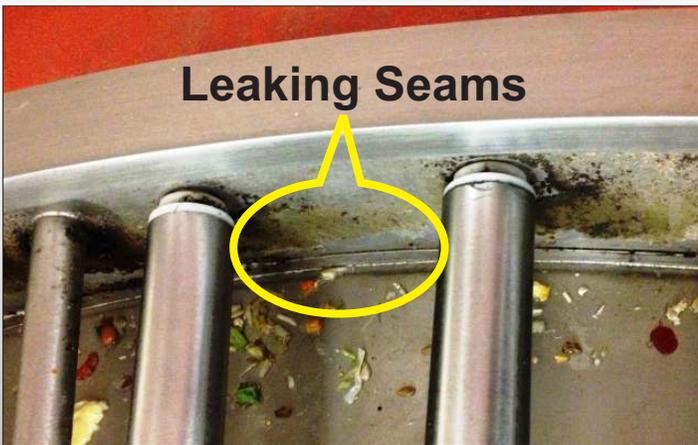
The hospital's maintenance engineers contacted the local ENECON Fluid Flow Systems Specialist with what they considered an 'unusual' problem. The seams of their stainless steel dishwashing tray line were leaking. This was causing slip/fall accidents, constant clean-up and generally unsanitary conditions.

The area's were manually prepared with sandpaper, then cleaned thoroughly. FLEXICLAD ER was applied, with no primer needed. The area was ready to be put back into action the next morning with no odor and no downtime.

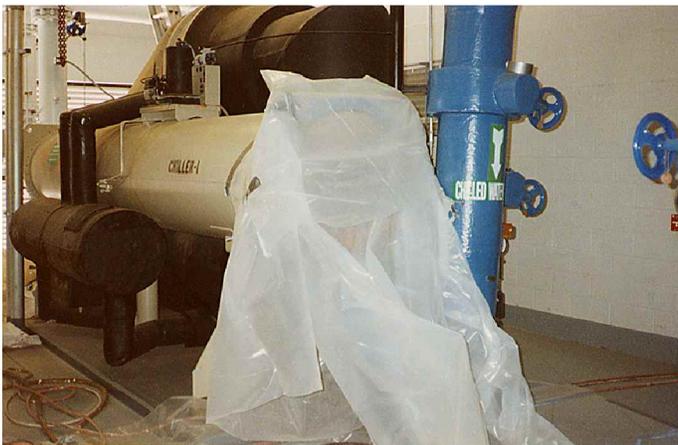
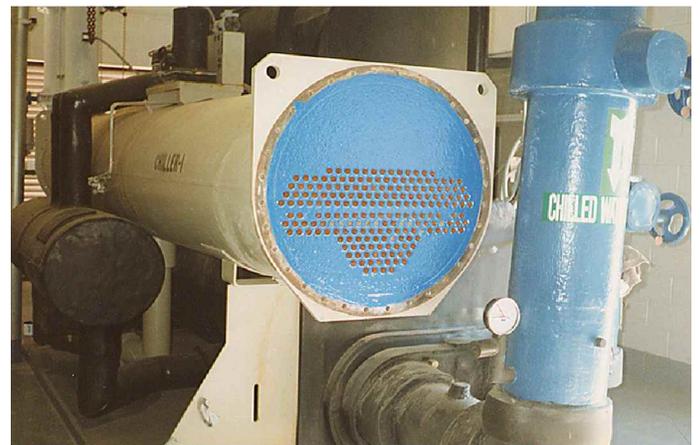
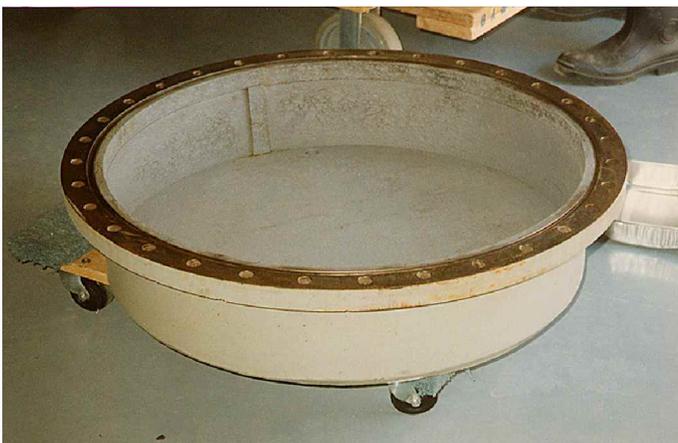
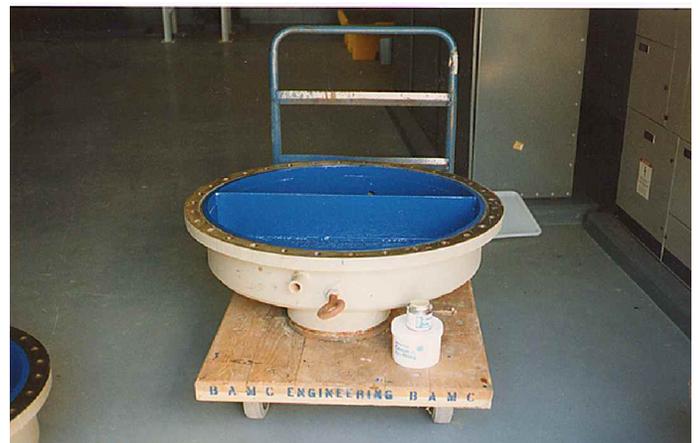
Erosion and Corrosion damage was evident on the chillers of their

air conditioning system and they wanted the best material to repair the damage and provide long-term protection from future damage.

effective solution...CeramAlloy CP+ and CL+ to rebuild any damaged metal and then resurface the end covers as well as the tube sheets on the chiller.

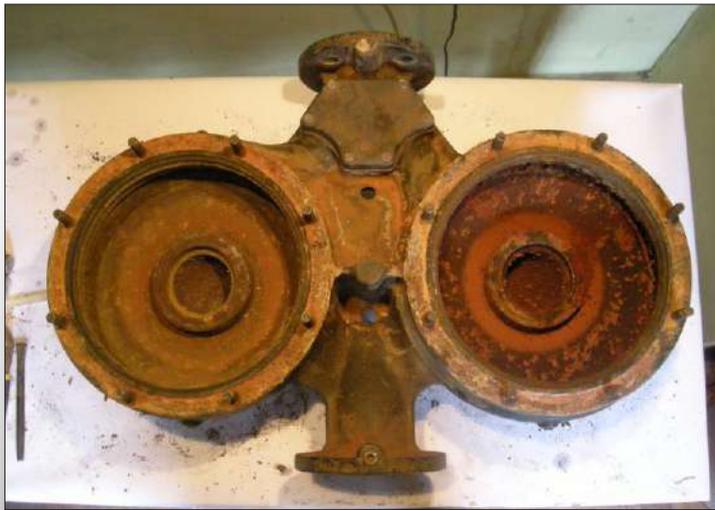
This hard water pump at a hospital in Chile was only averaging a few months in service before maintenance would have to be performed to repair deep erosion / corrosion damage.

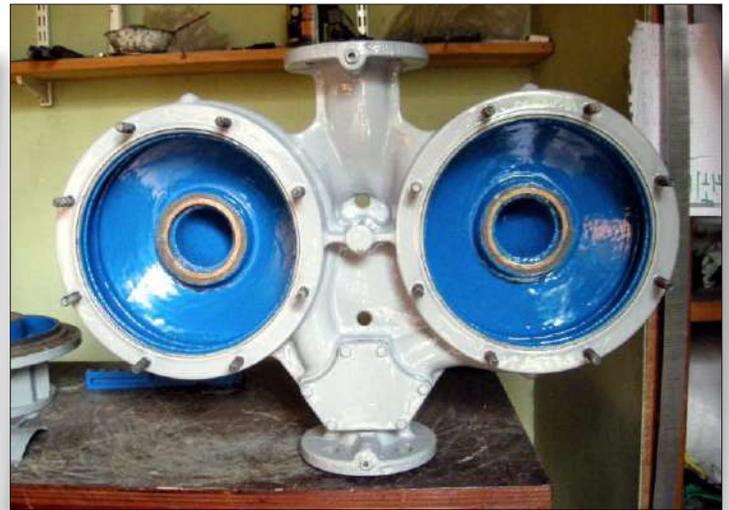
After thoroughly grit blasting, all deeply damaged areas were repaired with CeramAlloy CP+AC. Two coats of CeramAlloy CL+AC were then applied to provide erosion / corrosion resistance.
