U.S. Based Marine Company Uses CHEMCLAD SC to Salvage & Protect Pier Fender

Italian Coast Guard Selects CHEMCLAD XC To Solve Corrosion Issues

Spanish Navy Protects Cargo Deck with CHEMCLAD SC Non-Skid Safety System.

After 13 Years, CHEMCLAD Holds Up On MSC Hospital Ship's Laundry Decks

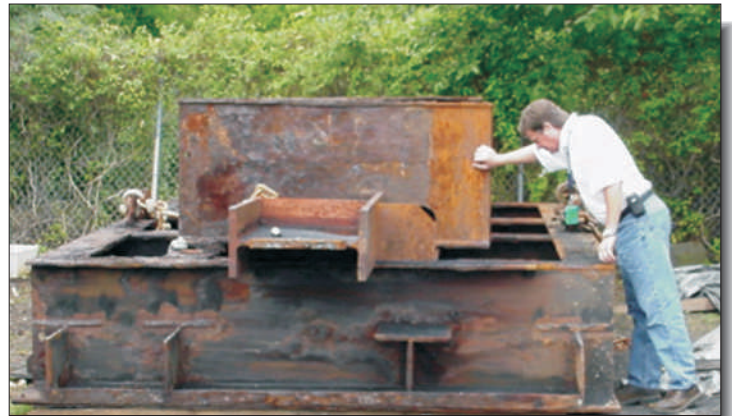
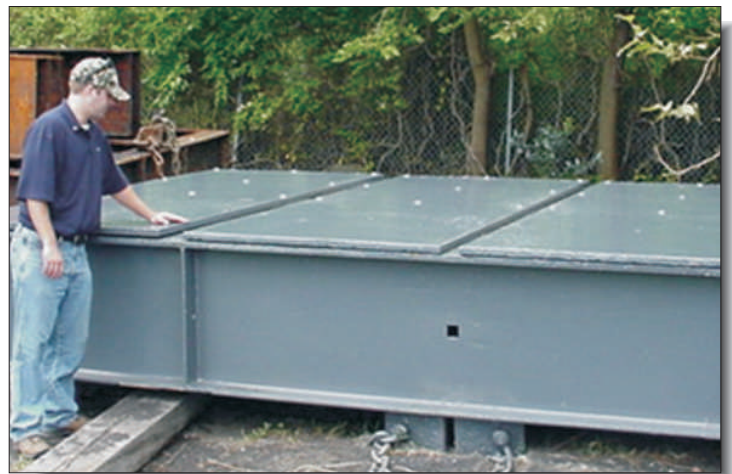
This 10 ton pier fender, used as a buffer between concrete pier pilings and boat hulls, was over 10 years old and suffering from severe erosion and corrosion due to constant exposure to salt water and tidal changes.

The ENECON Engineering Specialist recommended that all the fender's deteriorated steel be cut out and replaced. Then all surfaces were thoroughly grit blasted and cleaned.

The first coat of **CHEMCLAD SC** gray was applied by airless spray followed by a second coat of **CHEMCLAD SC** light gray. A total of 40 units were used for this application.

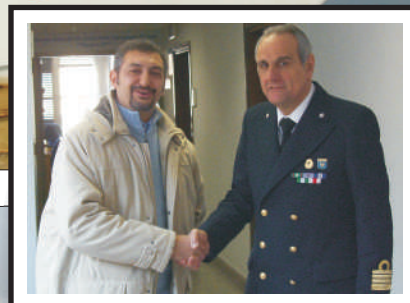
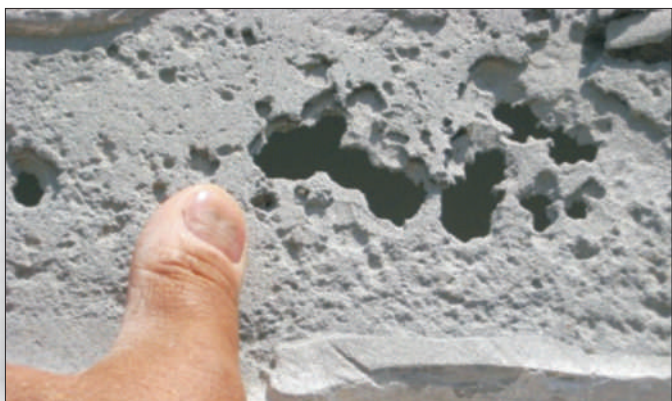
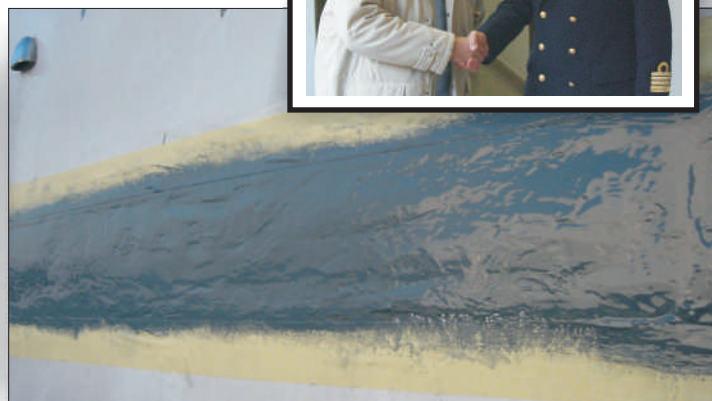
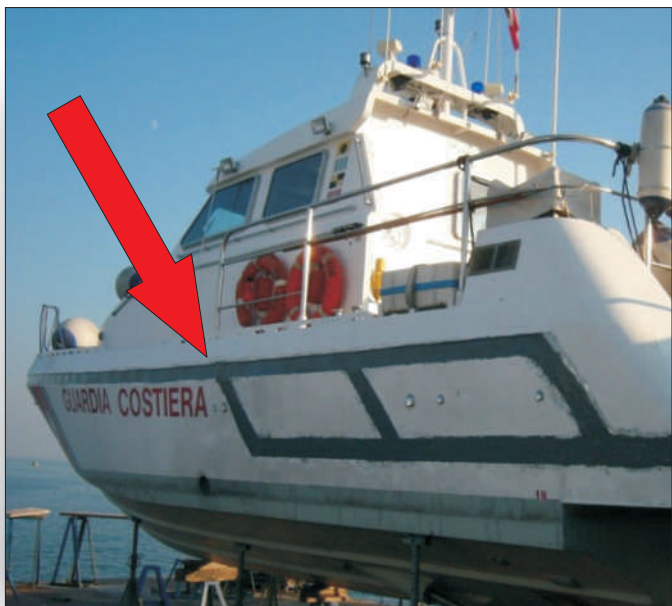
This Italian Coast Guard vessel had been experiencing some severe corrosion on its hull.

The affected area was first grit blasted to remove all corrosion and prior coatings. The entire area was then rebuilt with 6 mm of CeramAlloy CP+AC and reinforcement mesh.

This repaired area was then protected with CHEMCLAD XC.

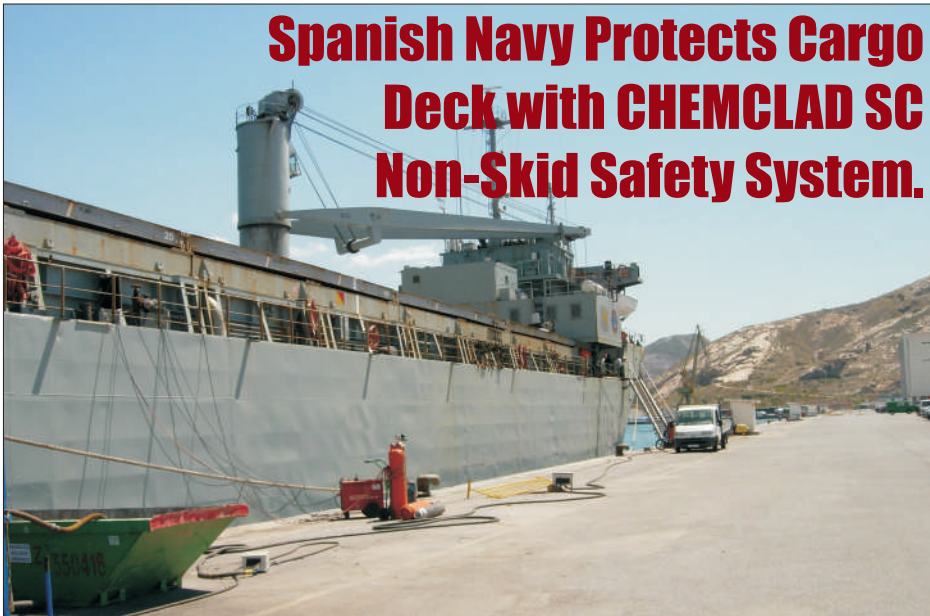
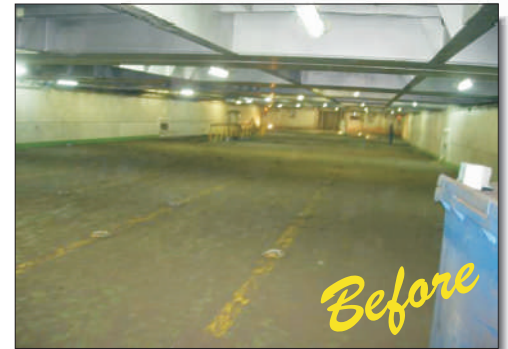
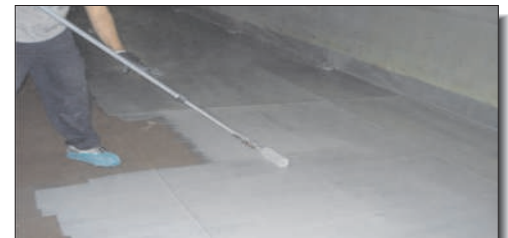
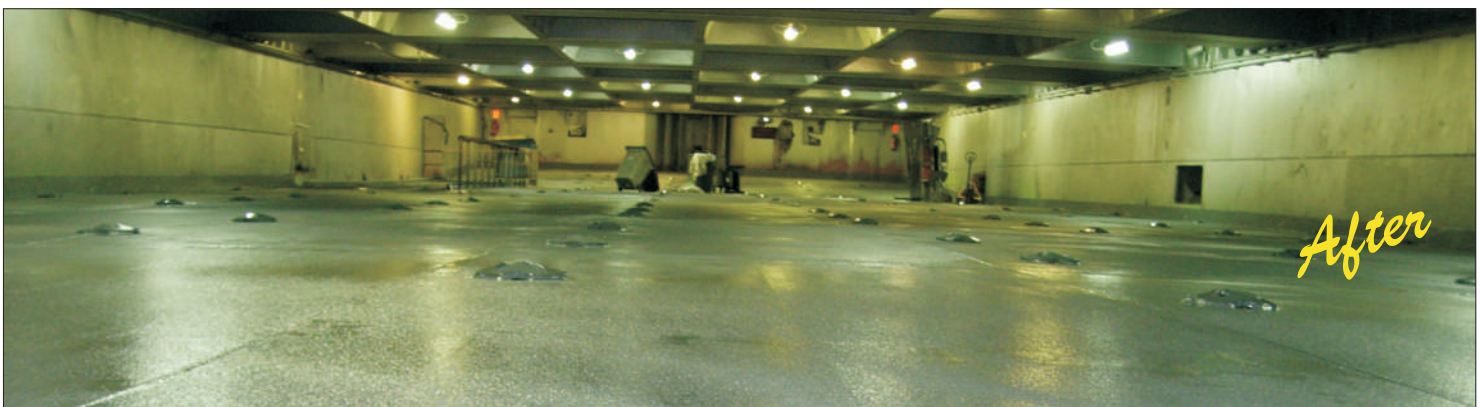
The hangar floor on this Spanish Naval vessel, used to transport tanks and other heavy vehicles, had been suffering from corrosion as a result of the failure of a conventional paint system.

The ENECON Specialist recommended that a complete *CHEMCLAD SC System*, incorporating aluminum oxide aggregate to provide slip-resistant safety surfacing, be applied to protect this floor from further corrosion damage.

The first coat of *CHEMCLAD SC* was rolled out. To provide slip-resistance, aluminum oxide aggregate was broadcast and back-rolled into the *CHEMCLAD SC* as it was applied.

A final topcoat of *CHEMCLAD SC* was then applied - giving the Navy a slip resistant,

easy to clean surface that would resist damage from gasoline, oil and hydraulic fluid while protecting the deck from corrosion for many years to come.

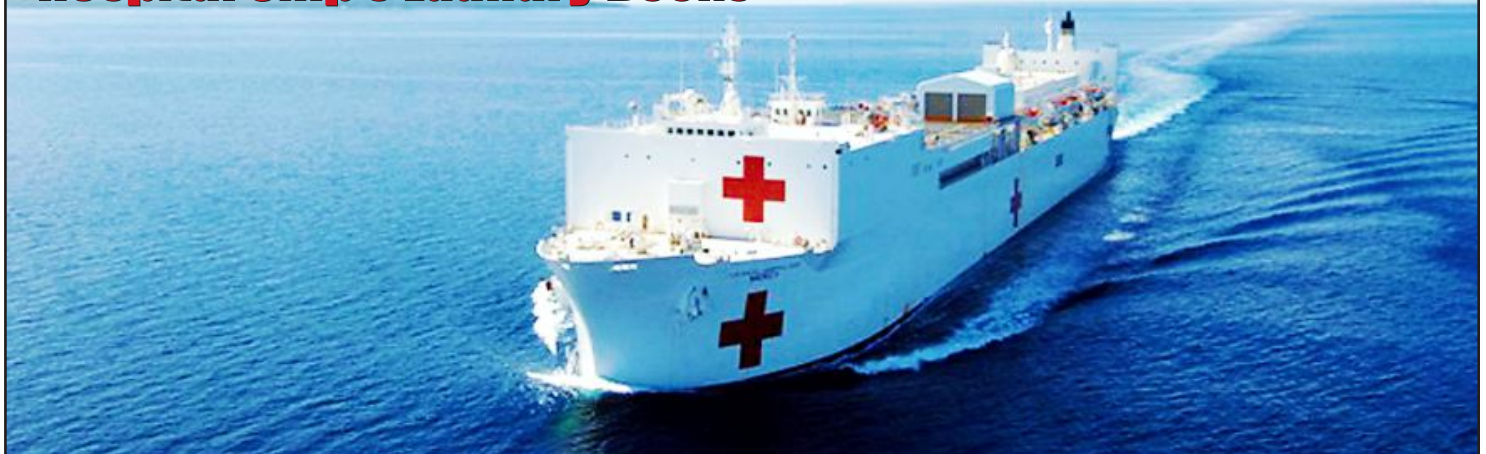
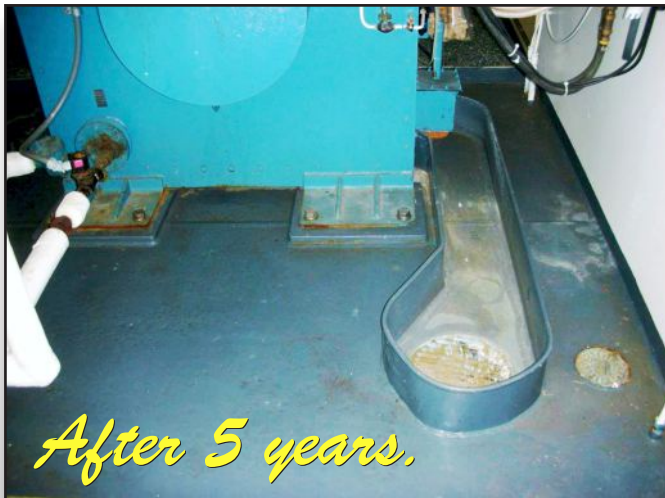
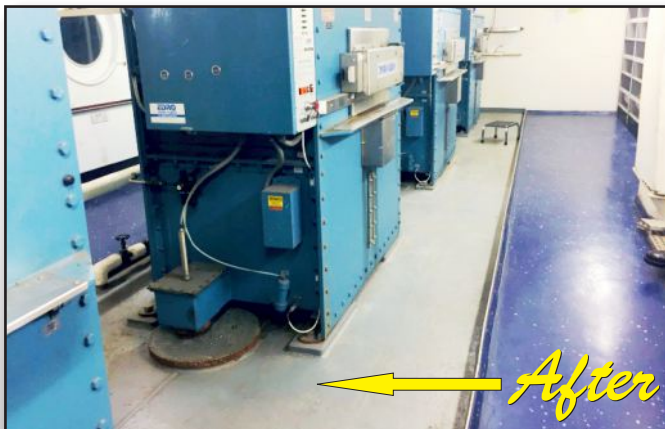
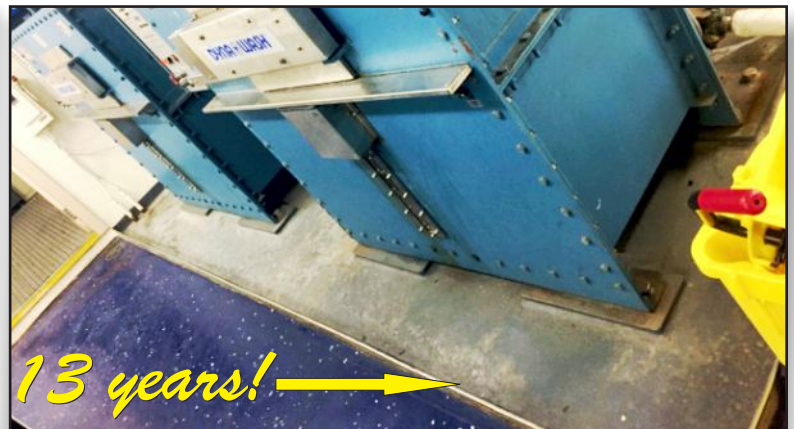
The ship's laundry room decks were corroded from industrial washing machine spillage. Originally the ship's Port Engineer wanted to install a stainless steel liner atop the carbon steel deck. After consulting the local ENECON Field

With over 1,000 beds on this ship, the floors of this laundry room can be a corrosive place. CHEMCLAD SC has eliminated this threat for over a decade.

Engineering Specialist, it was recommended that the floors be grit blasted followed by 2 coats of CHEMCLAD SC.

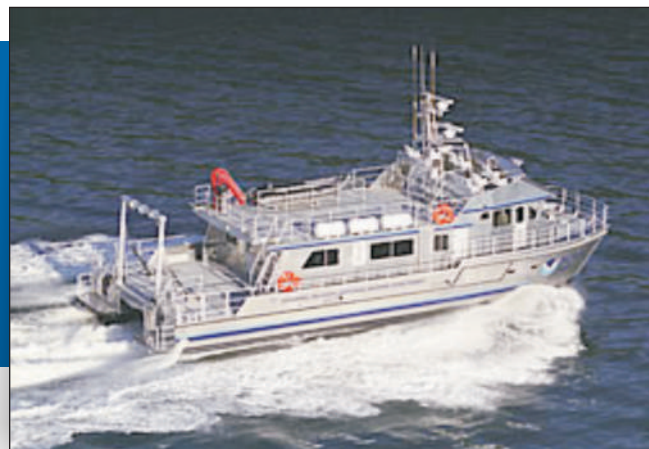
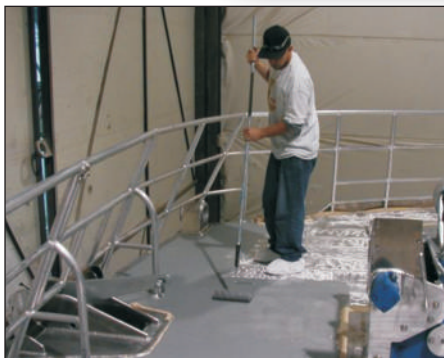
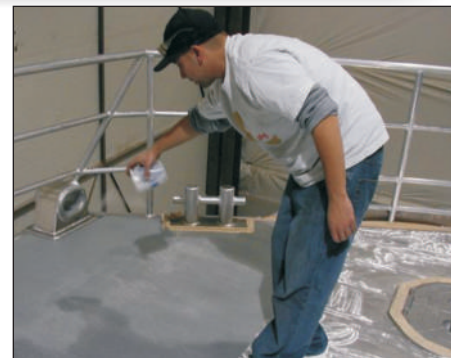
This aluminum hull catamaran is designed to be used as a research platform in one of the National Marine Sanctuaries. The marine engineers wanted a high performance, non-slip deck coating that would provide many years of service. They selected ENECLAD FPS because of its durability and ease of application (no odors or V.O.C's) and ease of cleaning.

Due to blasting constraints imposed by the client in their building, it was decided to grind the aluminum with a 24 grit disc on a 4-1/2" side grinder to roughen the surface. The deck was then wiped down with a commercial solvent. The FPS was applied using a 1/4" nap, shed-resistant mohair roller. The initial coat of FPS was applied at 12 mils followed by a broadcast of aggregate to provide a non-slip surface texture. The aggregate was then encapsulated with a final back-roll of FPS. \$10,000 worth of ENECLAD FPS was used on this project.

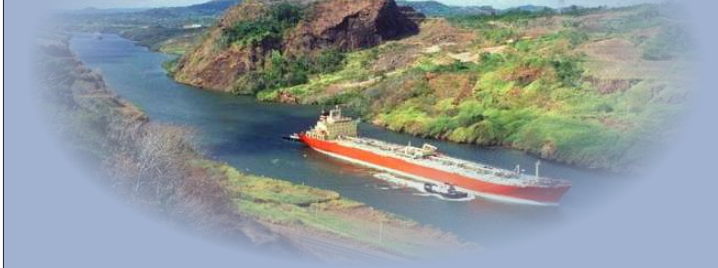
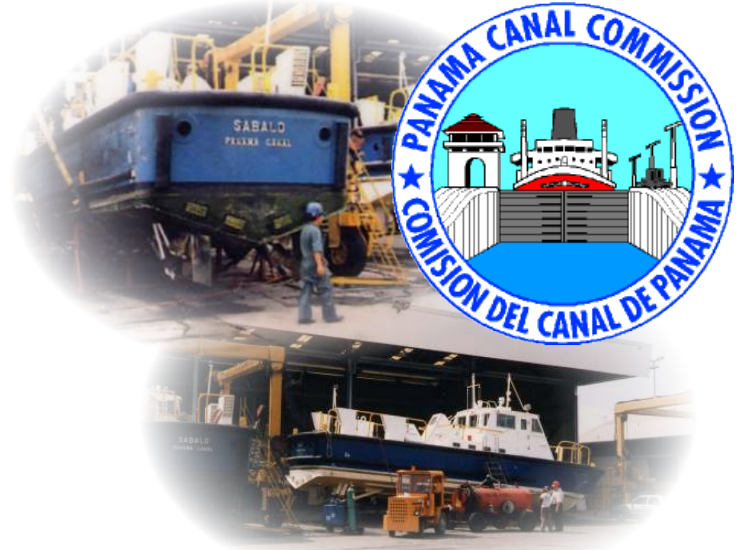
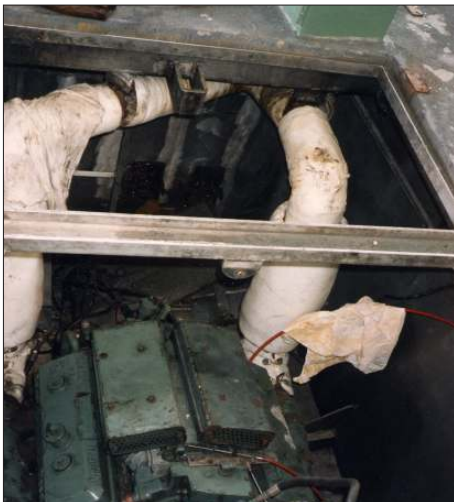
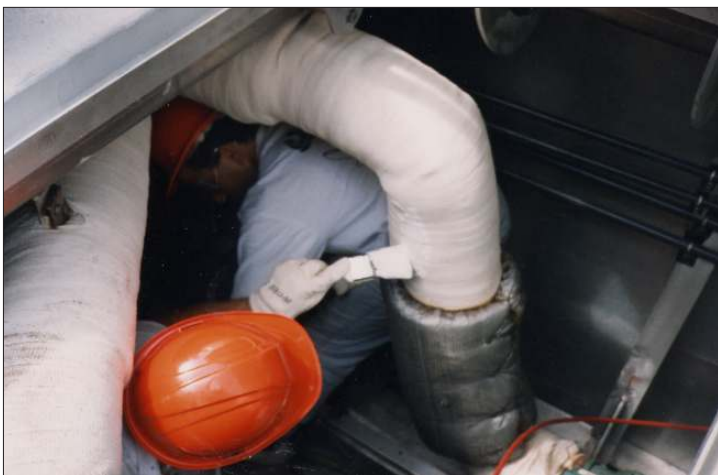
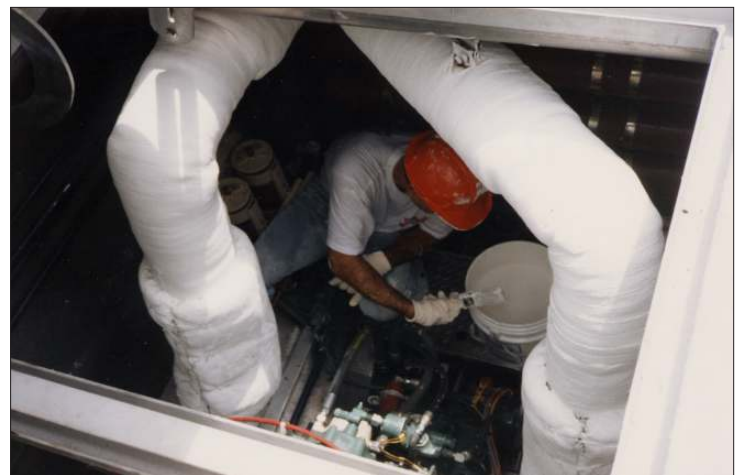
damage is the fact that the insulation is also subject to oil impregnation, creating a potential fire hazard.

The insulation on the exhaust systems of the twin diesel engines is subject to splashing by both salt and fresh water. In addition, mechanical damage during maintenance checks is a virtually unavoidable problem.

In an effort to protect the insulation from these damaging and dangerous conditions, the Panama Canal engineers selected ENECON ENESEAL HR to completely seal and encapsulate the insulation.

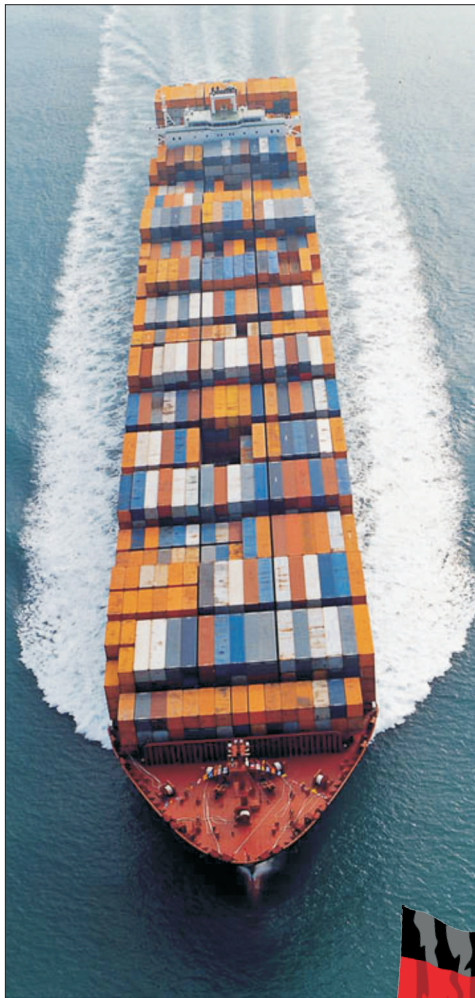
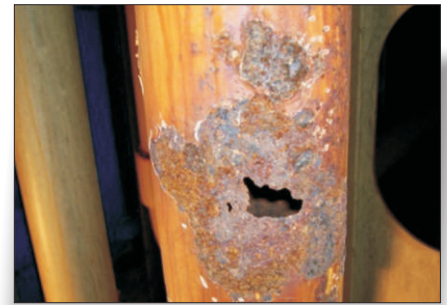
Oil tank ventilation pipes located on German container vessels, part of a major German shipping line, were suffering from heavy corrosion causing pitting and massive holes in the pipes. Damage of this nature to these pipes would cause oil leaks as well as vapor leaks which could be a health risk to those on board.

Holes caused by corrosion

After minimal preparation of the pipes, the large holes were repaired with stainless steel patches shaped to the contour of the pipes and adhered using DurAlloy. A first coat of ENESEAL CR was then applied. The pipes were wrapped with a fiberglass reinforcement tape and then overcoated with a second layer of ENESEAL CR creating a highly durable, corrosion resistant, elastomeric 'skin' providing extraordinary environmental protection.

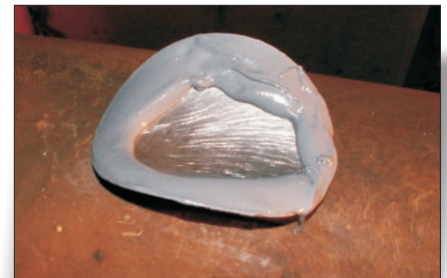
Stainless steel patch with DurAlloy

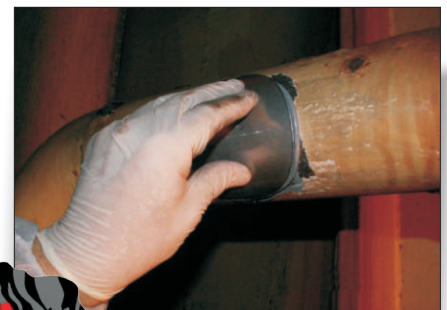
Patch applied to hole

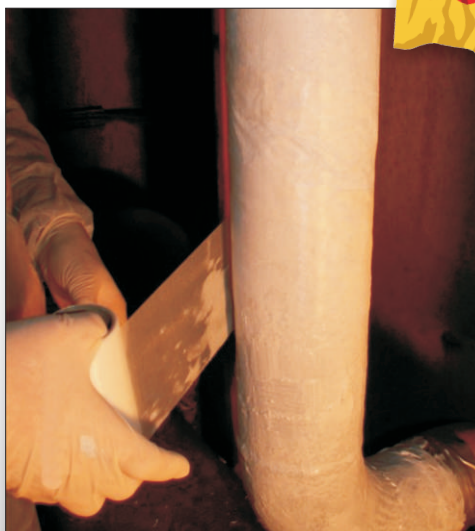
Fiberglass reinforcement tape over 1st coat of ENESEAL CR

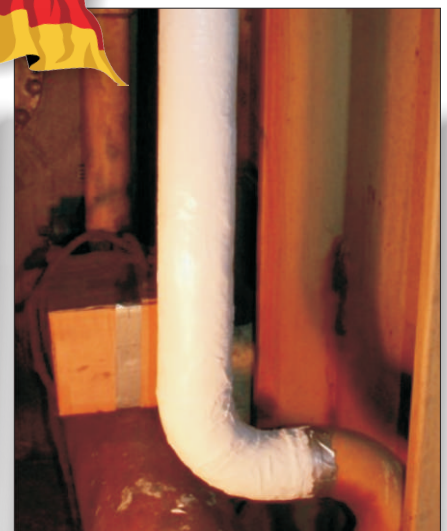
Final coat of ENESEAL CR

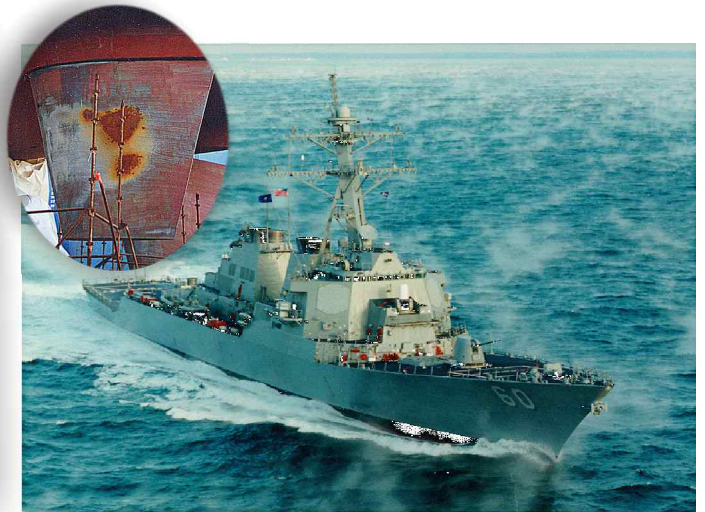
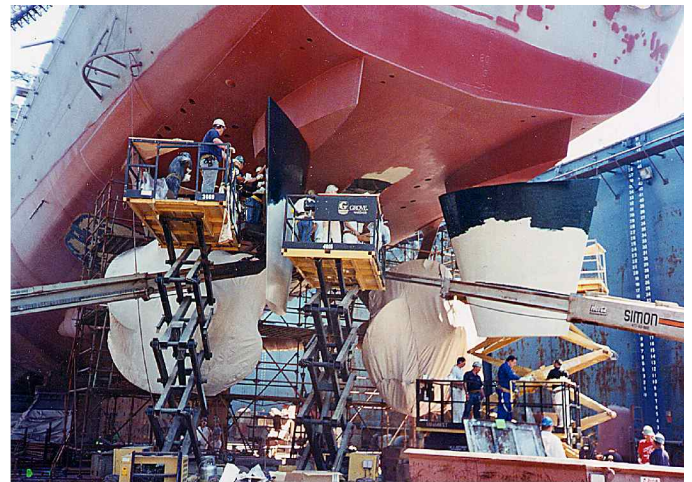
After an extensive, two-year evaluation program, the U.S. Navy selected ENECON's DuraTough elasto-ceramic, polymer composite as the high performance material of choice to protect components on its newest Aegis Destroyers from severe cavitation damage. Rudders -- and in some cases struts and barrels -- on the latest Arleigh Burke Class

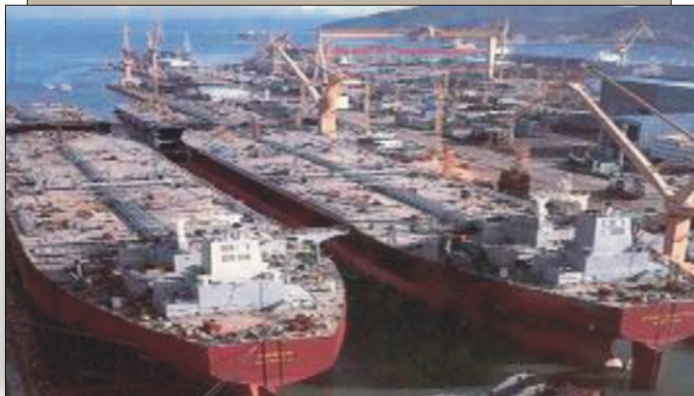
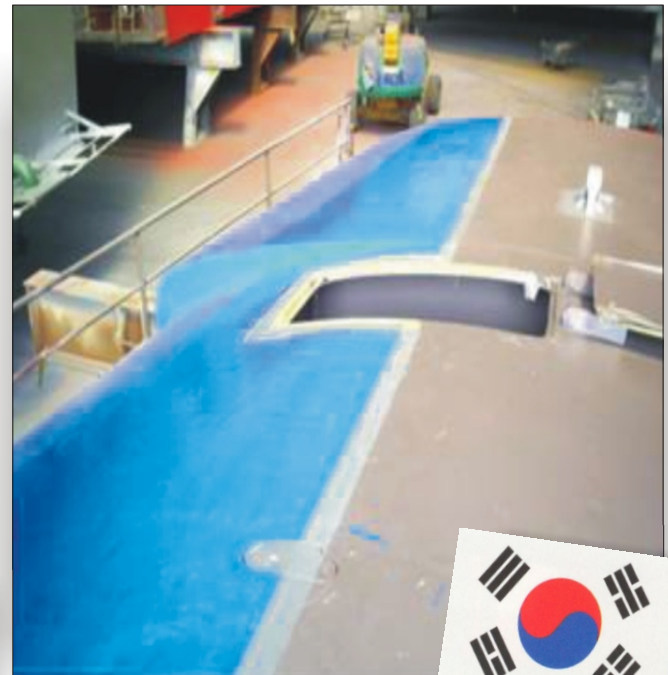
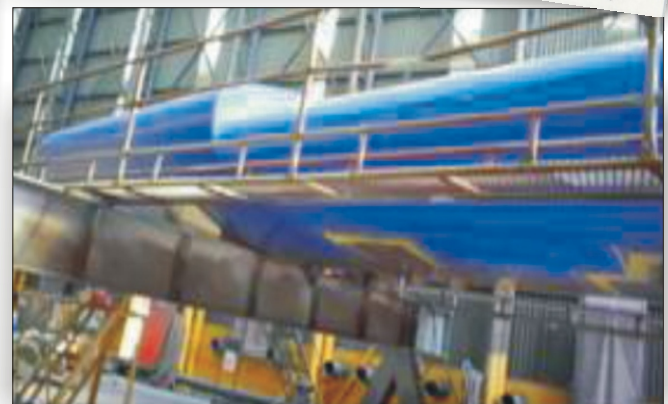
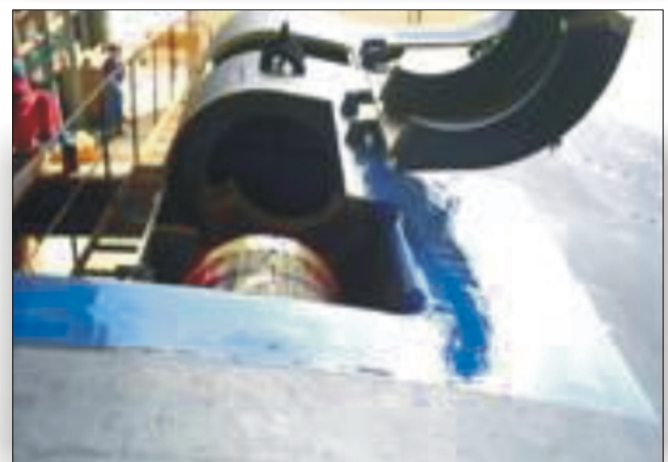
One of the largest international shipbuilding and engineering companies based in Korea was looking for the best repair and protection solution for their cavitation issues. Over the years they had tested numerous products and techniques but all of these provided only limited protection and were deemed unsuccessful.

commercially proven solution. ENECON Korea suggested a standard DuraTough DL application in the high cavitation zones followed by CeramAlloy CL+AC over the leading edges of the DuraTough to protect them.

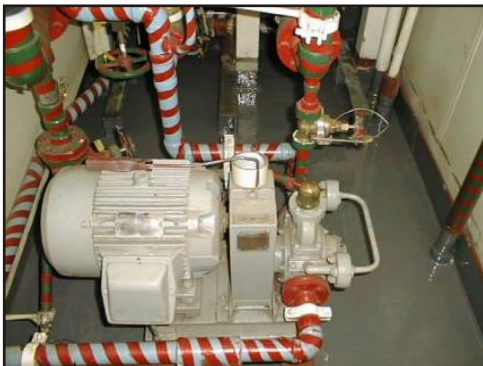
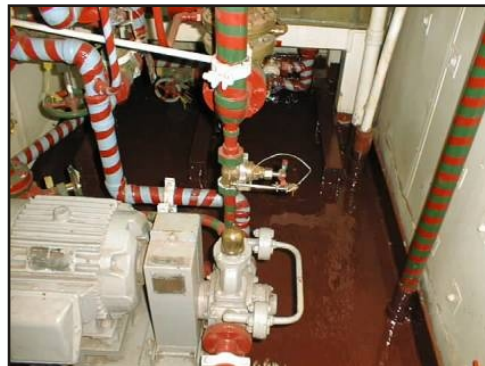
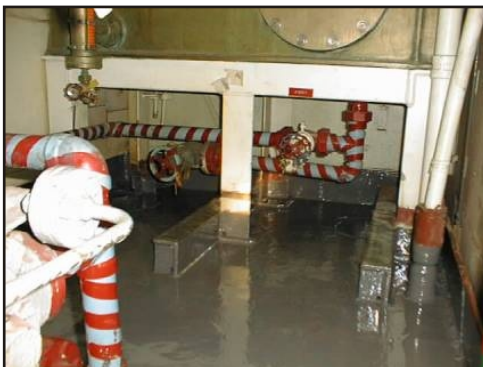
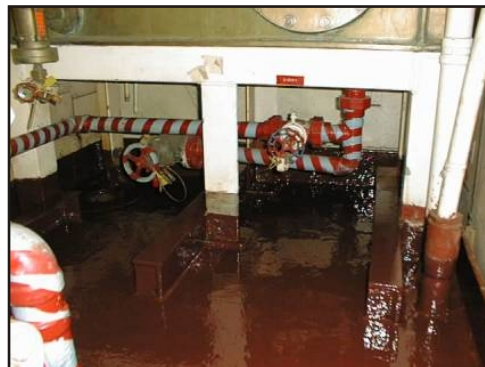
First coat of CeramAlloy Grey color followed by a second coat of CeramAlloy AFFF Red

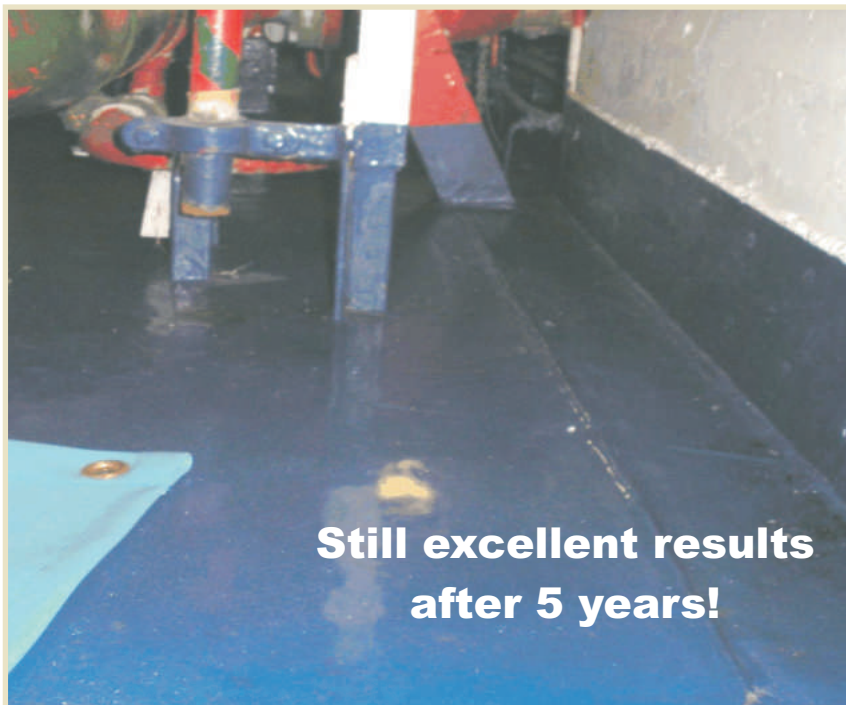
**Still excellent results
after 5 years!**

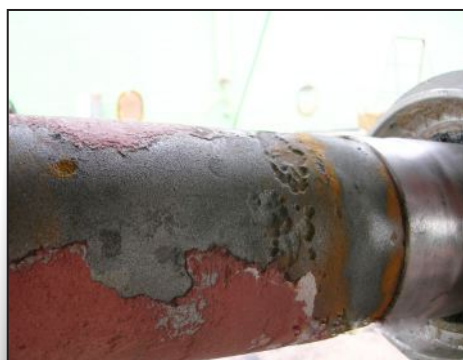
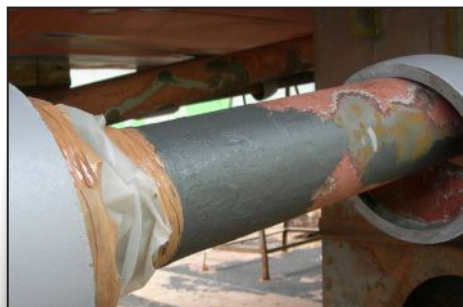
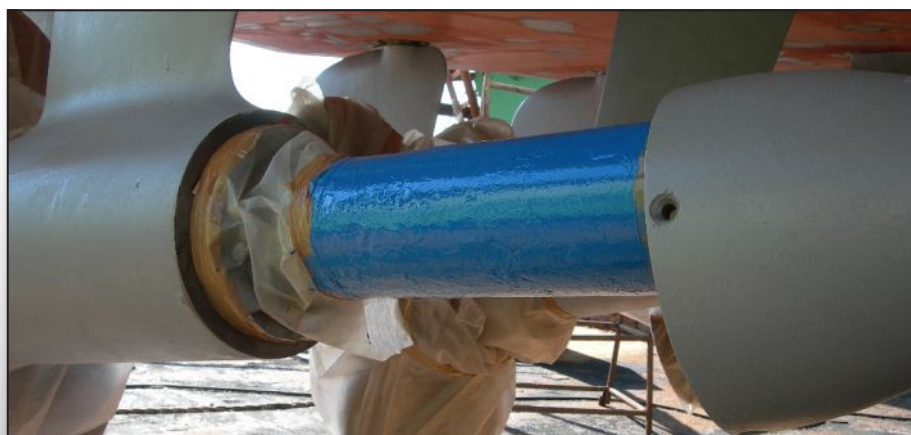
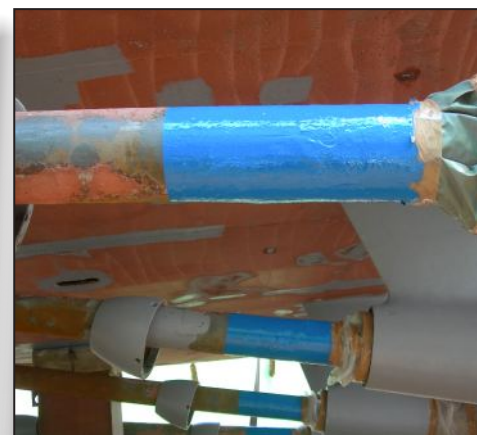
The propeller shafts on this Croatian Naval ship were suffering from severe erosion / corrosion in the areas around the struts and before the propellers. This was due to many years of operation in a harsh salt water environment.

Previously applied epoxy coatings had failed and the ship's engineer was looking for a long lasting, cost effective solution.

ENECON Croatia was contacted and it was recommended that a combination of CeramAlloy CP+AC and CL+AC be used to repair the existing erosion / corrosion damage and to protect against future damage.

CeramAlloy CL+AC were then applied.

After first grit blasting the damaged areas, a layer of CeramAlloy CP+AC was applied to rebuild the damaged areas. Two final coats of

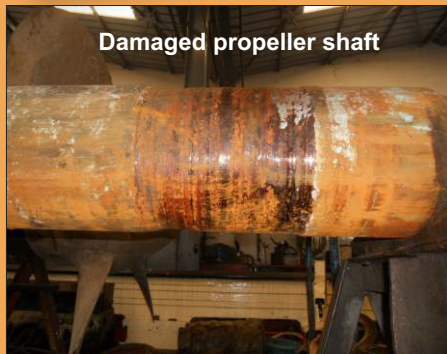
Problem: A 20-year-old fishing boat propeller shaft was suffering from severe erosion. Replacement shafts cost in excess of \$15,000.

Damaged propeller shaft

Solution: DurAlloy was used to rebuild the shaft's thickness. It was then machined down to a smooth finish. Finally two coats of CeramAlloy CL+AC were applied to provide maximum erosion and corrosion protection. The customer was so pleased with the results, ENECON Morocco has had 6 more propeller shaft repair/protection projects.

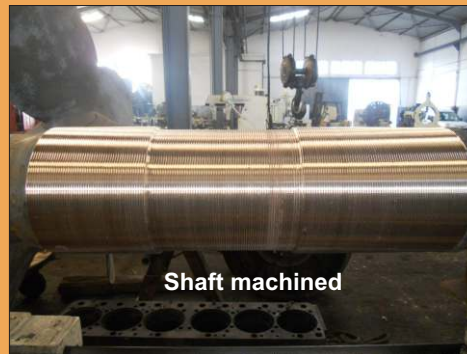
Shaft machined

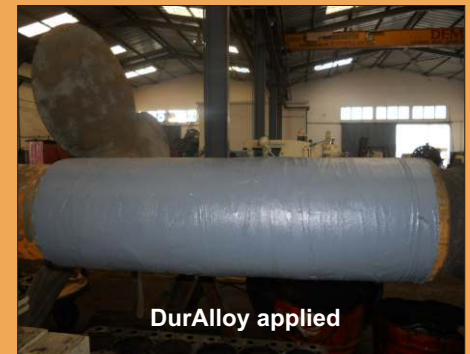
DurAlloy applied

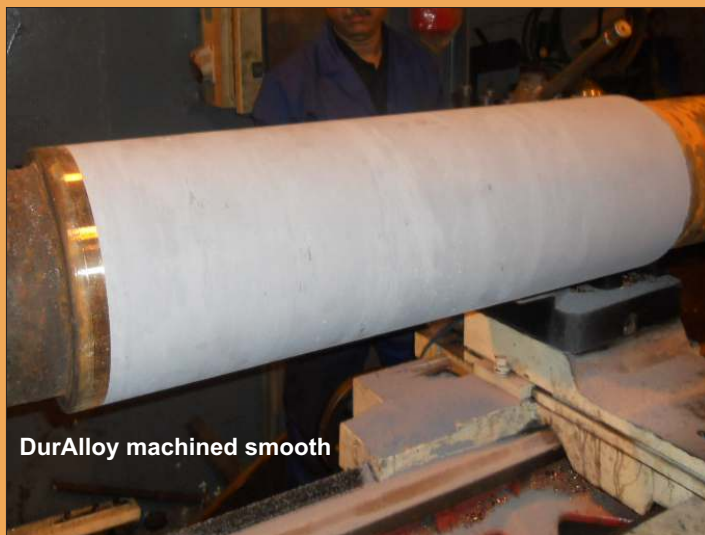
DurAlloy machined smooth

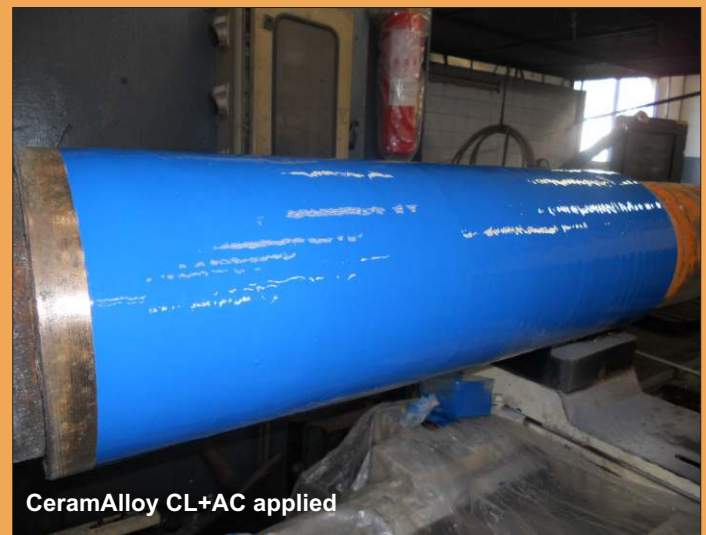
CeramAlloy CL+AC applied

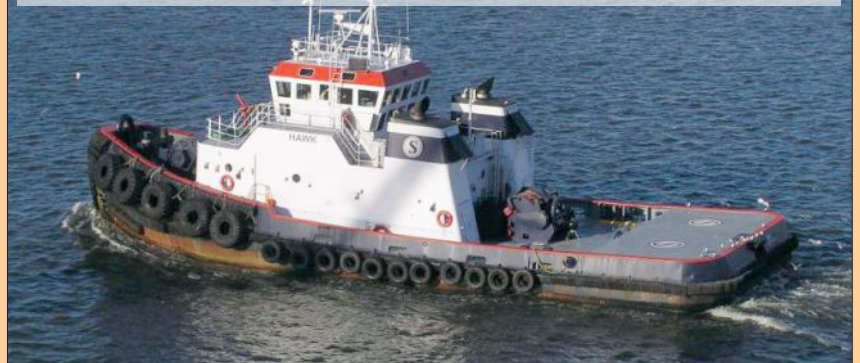
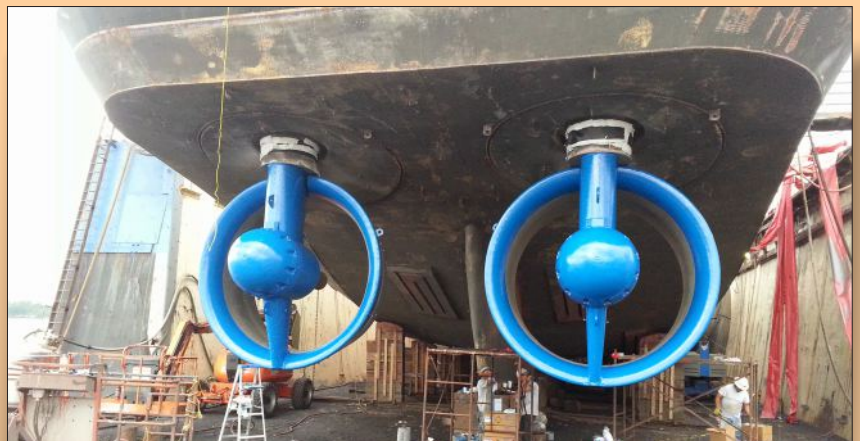
This tugboat belonging to a major international marine company in Florida was suffering from the effects of erosion & corrosion on its Kort nozzles. The local ENECON Fluid Flow Systems Specialist was called in to help find a solution.

After preparing the surface by grit blasting to acquire a 'white metal' finish, two coats of CeramAlloy CL+AC were applied.

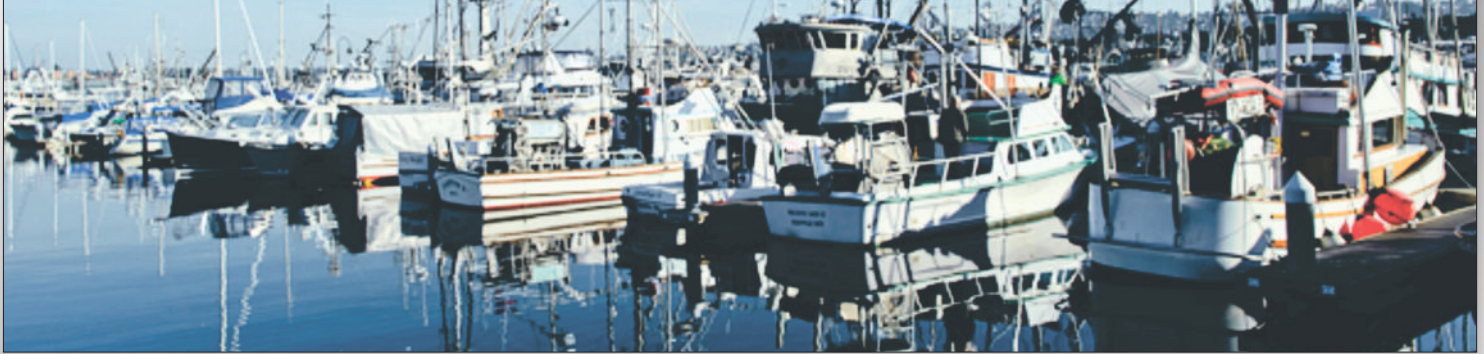
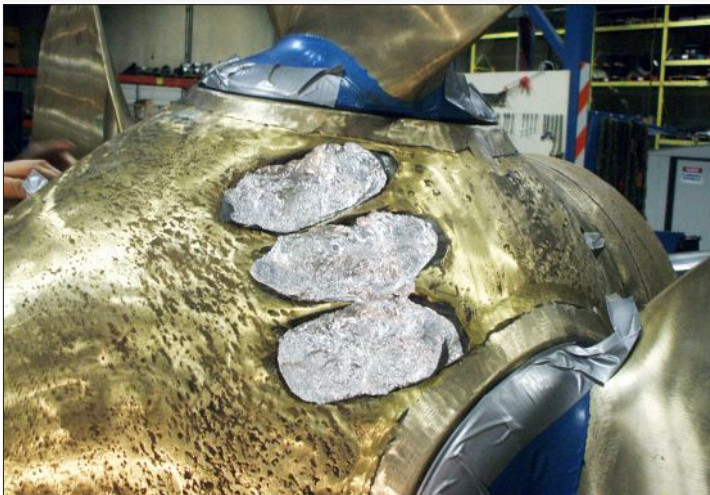
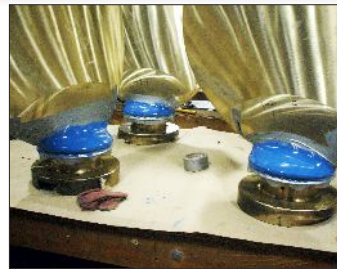
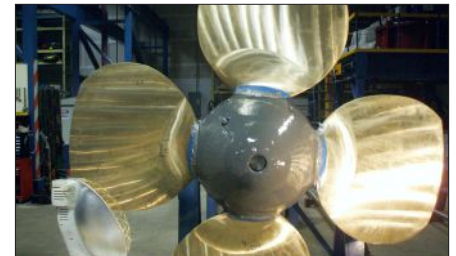
Controllable Pitch Propellers (called CPP 'wheels') are used by tug boats, fishing boats and many other commercial vessels. The pitch (angle) of the propeller blades can be adjusted for power, speed and even direction – all without changing engine speed. The hub of these propellers, as well as the base of the blades, often suffer severe erosion/corrosion damage. Problem solved.

CeramAlloy CP+AC and CL+AC have been used for years to repair these critical areas - eliminating the need for welding. ENECON's Project Engineer in the Seattle, WA, region has repaired dozens of these propellers with outstanding results using the application technique illustrated on this bronze propeller.

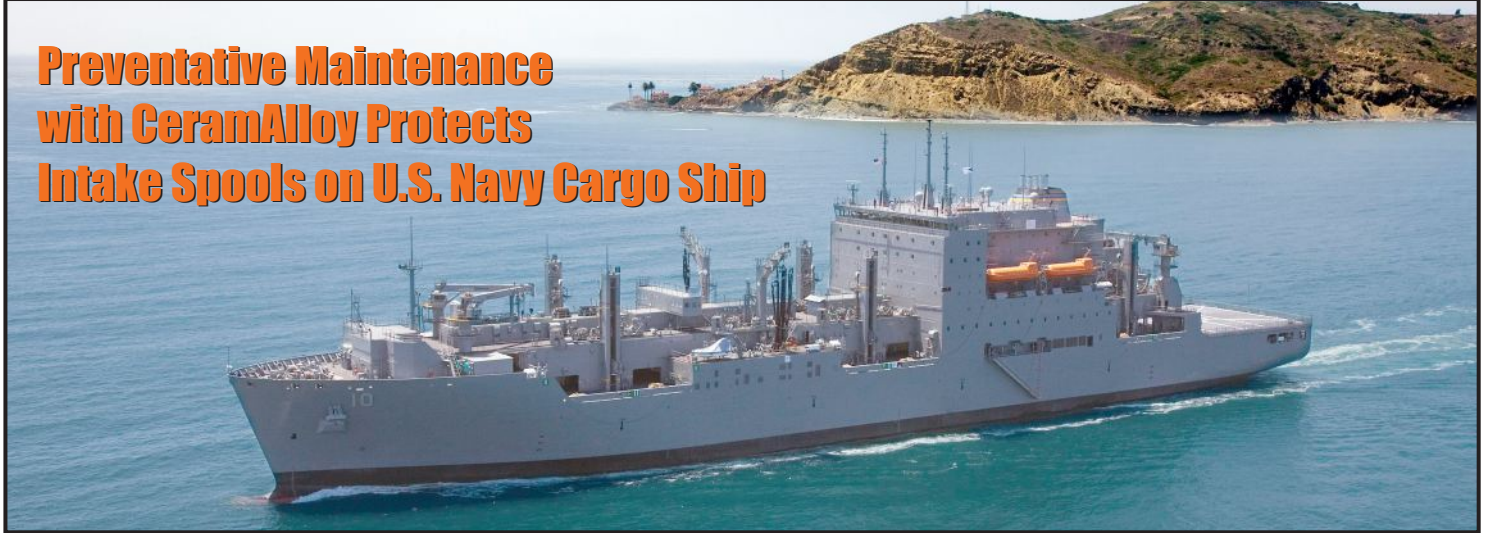
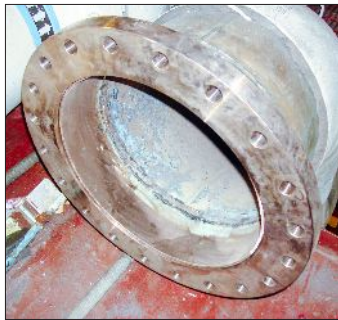
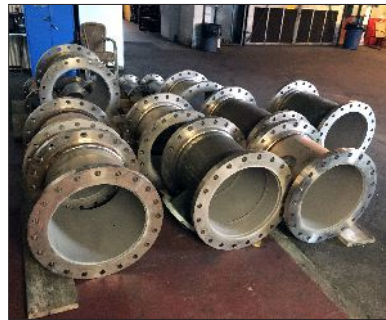
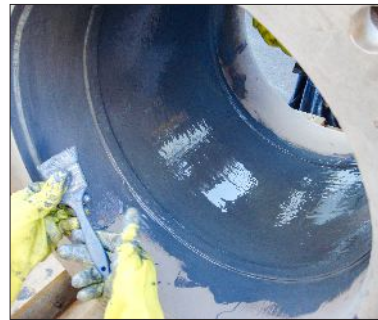
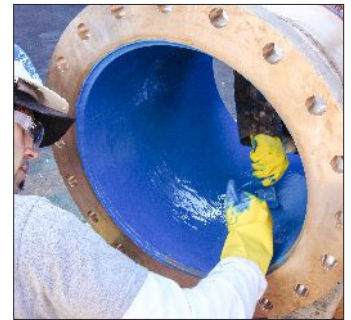
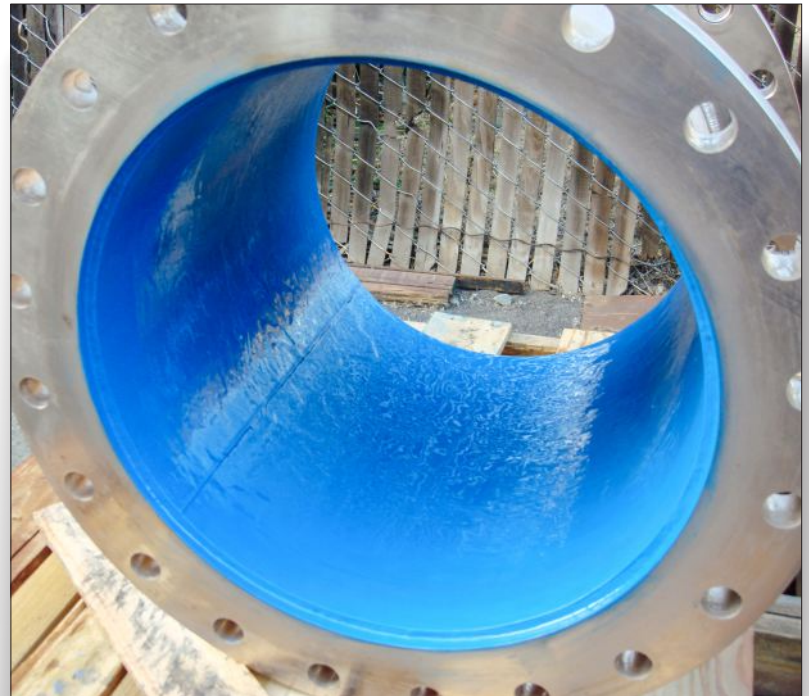
In order to extend the service life of new intake spools and transition lines being installed on a cargo ship, the Navy chose to proactively protect them with CeramAlloy CL+AC.

were applied to some 15 spool pieces and transition lines that carry sea water to the engine for cooling.

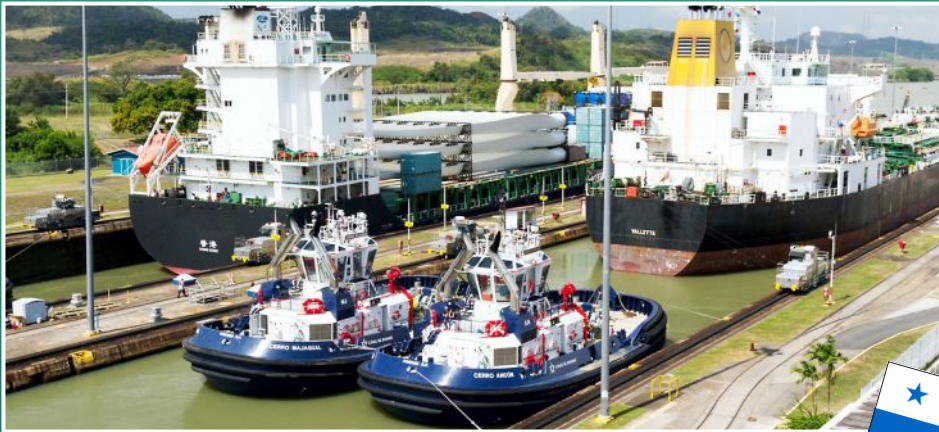
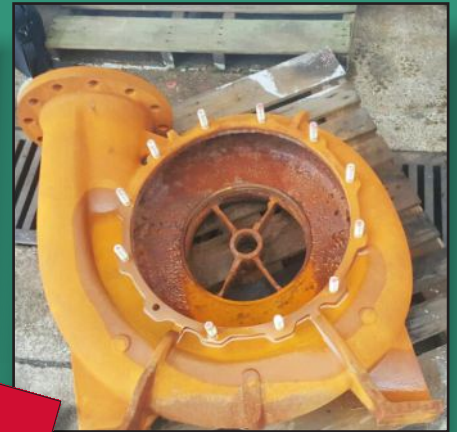
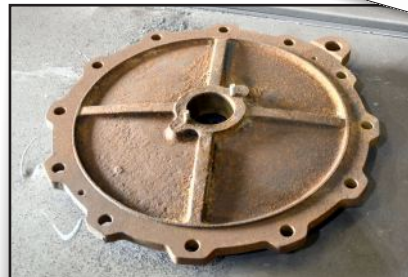
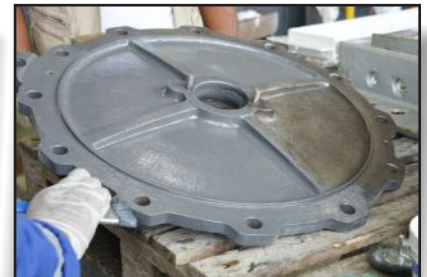
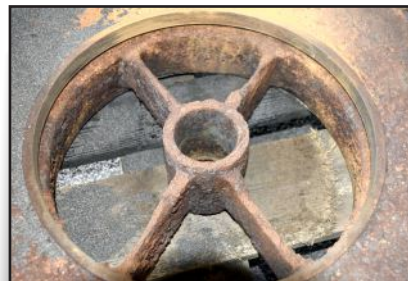
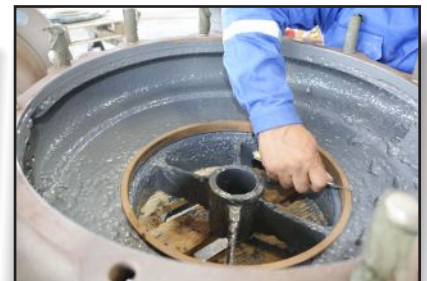
Constant exposure to salt water caused the entire surface of this pump to suffer from erosion and corrosion. This caused a weakening of the metal which then reduced the pump's efficiency in addition to leaks at the seams.

After grit blasting the pump and all of its components, a first coat of CeramAlloy CL+AC was applied to wet out all surfaces. CeramAlloy CP+AC was then used to rebuild the weakened and damaged areas. Then a final layer of CeramAlloy CL+AC was used to protect the pump from future erosion and corrosion problems.

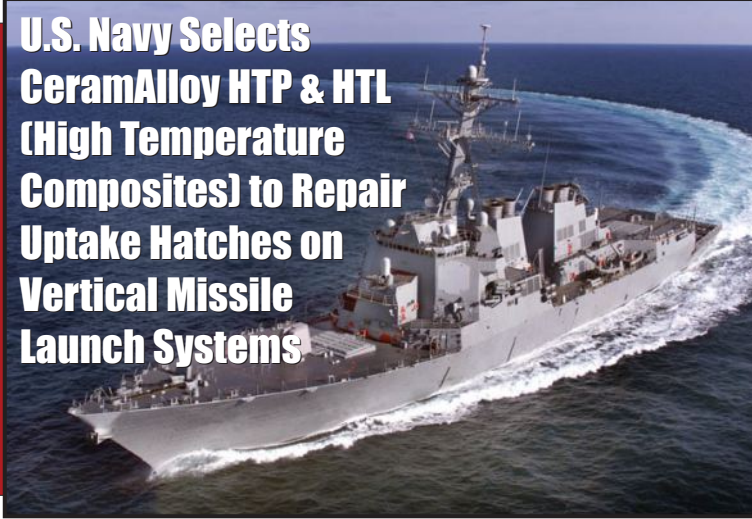
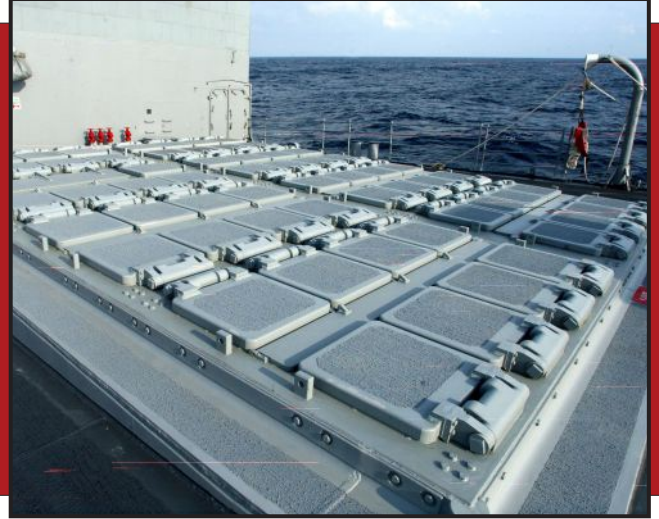
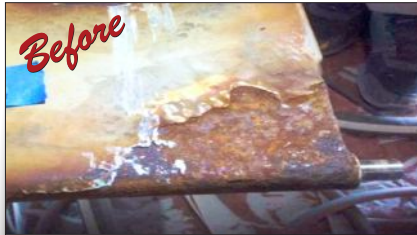
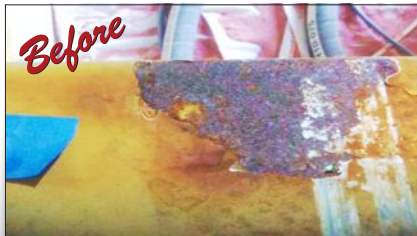
The U.S. Navy was in need of a solution to stop corrosion on their VLS (vertical launch system) uptake hatches on destroyer and cruiser class ships

were causing premature coating failure of the hatches.

Missiles are launched through open uptake hatches, usually located on the deck of a ship. The extreme high temperatures (400°F+), oxidized spent rocket fuel and environmental conditions of salt water

Then two coats of CeramAlloy HTL were applied to resurface and protect the entire area.

ENECON's high temperature resistant repair and rebuilding composite, CeramAlloy HTP, was used to repair and rebuild the severely eroded areas of each hatch. The HTP was then machined to maintain the required tolerances.

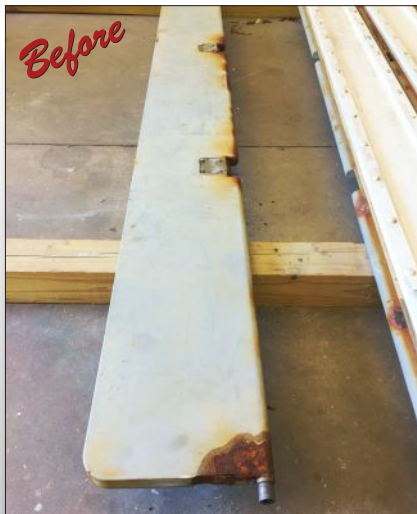
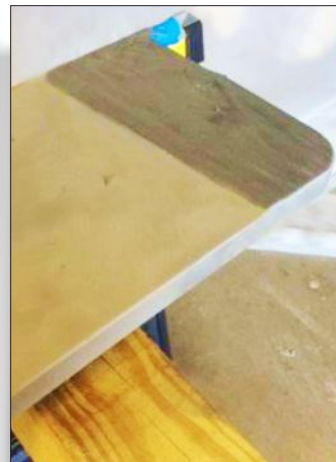
Repairs made with CeramAlloy HTP
