## Power Plant in Thailand Uses CeramAlloy and CHEMCLAD to Repair and Protect Cooling Water Pipeline

## ENECRETE, ENECLAD & CHEMCLAD Repair & Protect Containment Areas at Chilean Power Plant

## CHEMCLAD GP Continues to Fight Corrosion on Waste Removal Trailers

## Geothermal Energy Plant Rebuilds and Protects Acid Containment Area with ENECRETE & CHEMCLAD

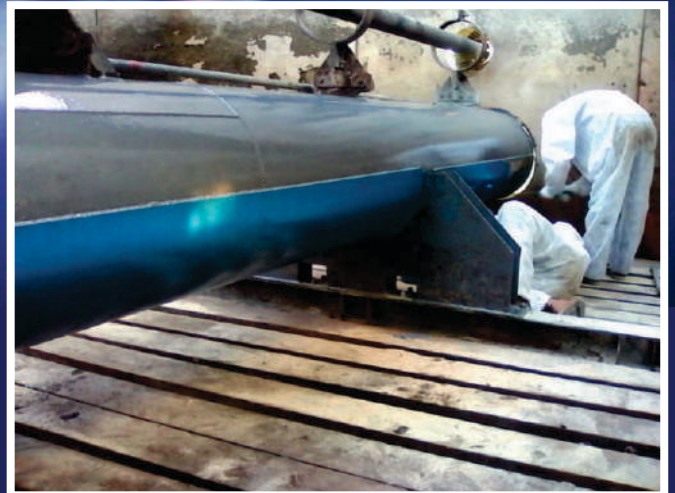
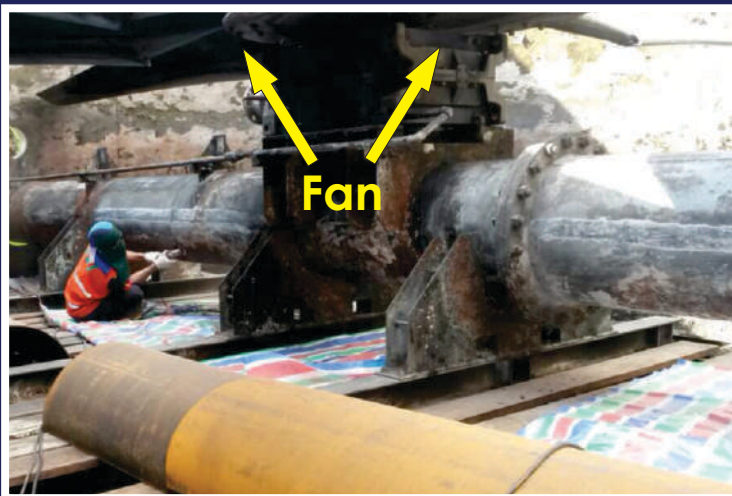
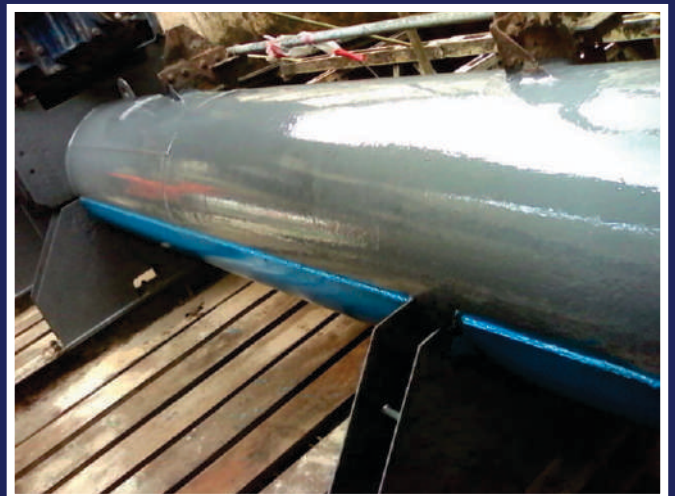
*This cooling water pipeline at a power plant in northern Thailand is subject to severe erosion and corrosion due to water forced out by the fans located on top of the pipes as seen in the bottom left photograph.*

*The bottom half of the pipe (only 2 mm / .08 inches thick in some areas) was repaired using welded plates which were bonded to the pipe with CeramAlloy CP+AC followed by two layers of CeramAlloy CL+AC.*

*The top of the pipe was coated with CHEMCLAD GP as a cost saving measure.*

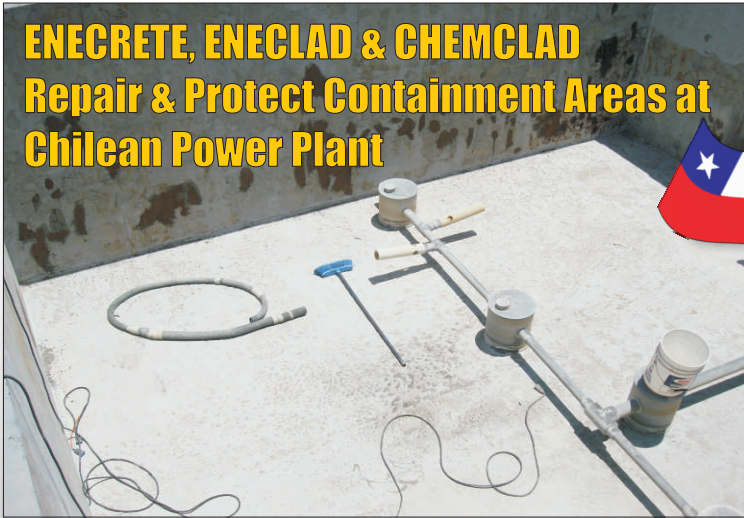
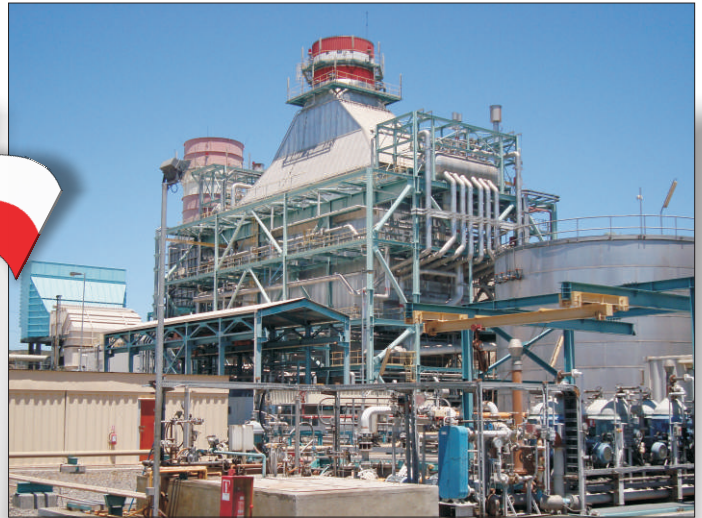
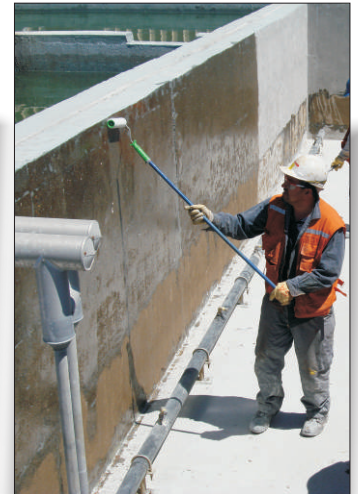
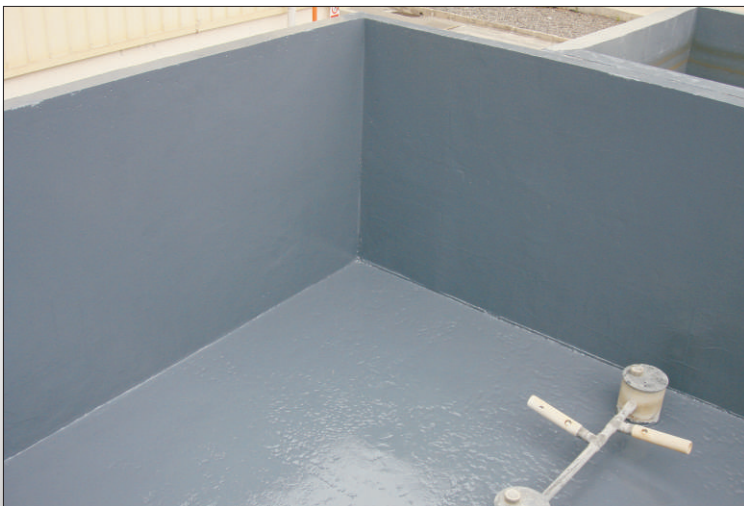
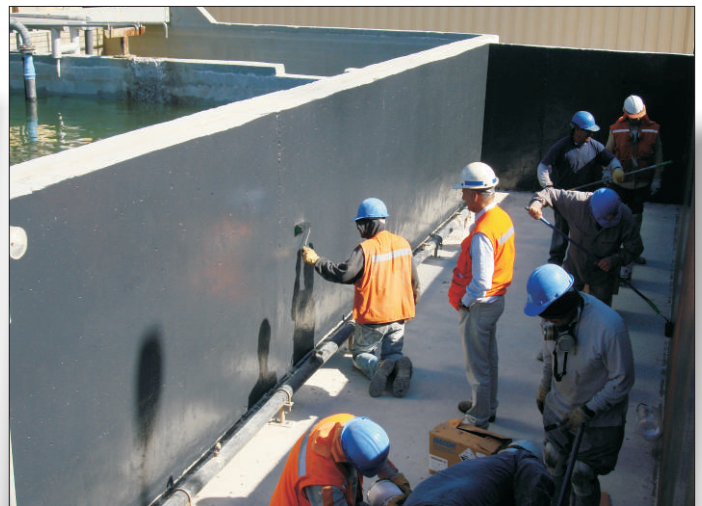
**Problem:** Corrosion of 3 concrete acid containment areas.

**Solution:** After mechanically cleaning concrete walls, ENECRETE DuraFill was used to repair all damaged areas. ENECLAD CFS was then applied followed by two coats of CHEMCLAD XC for maximum protection.

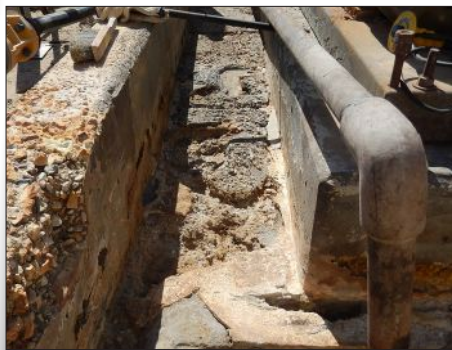
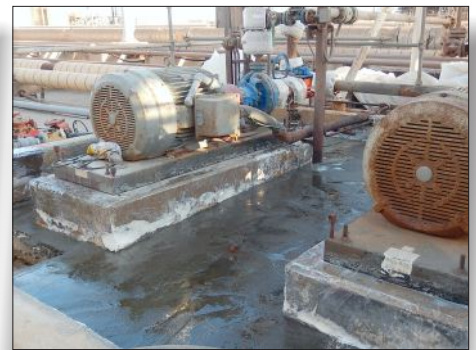
This high pressure acid pump containment area and its pump bases, located at a western U.S. geothermal energy plant, were crumbling and falling apart. These pumps are pumping 3% hydrochloric acid.

After a combination of hydro-blasting and manual preparation, 600 sq. ft. of concrete was repaired and rebuilt with ENECRETE DuraFill mixed with locally sourced aggregate.

CHEMCLAD P4C was used to prime all the areas since the DuraFill was not applied to the entire concrete surface. 2 coats of CHEMCLAD XC were then applied to provide maximum chemical protection to this critical containment area.

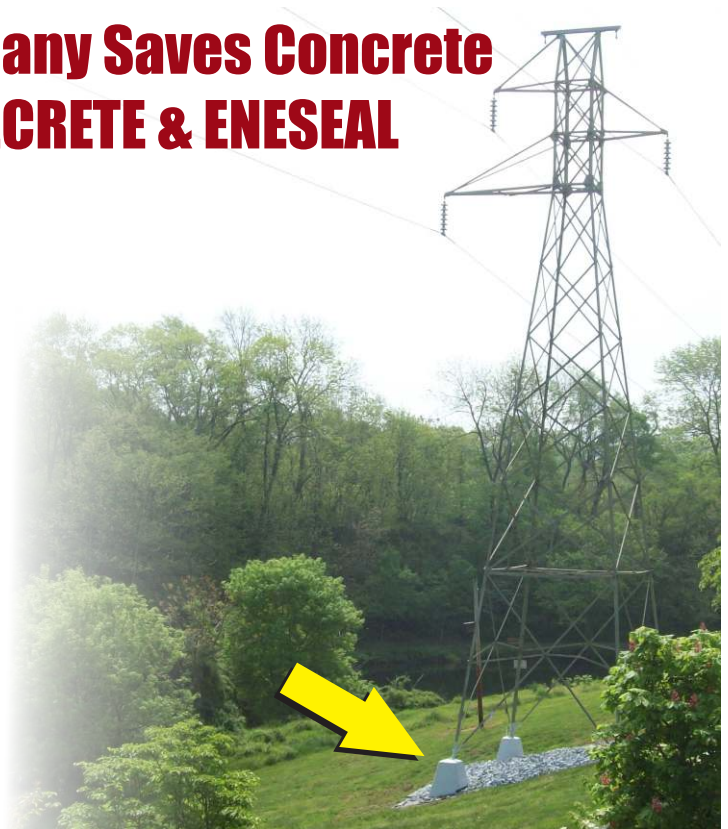
**Problem:** Electrical tower concrete base was crumbling due to exposure to the elements.

**Solution:** Loose concrete was manually removed and the base was enclosed with a wood former to re-build its shape. **ENECRETE DuraFill** was mixed with sand and pea gravel and then poured into the former.

After removing the wood former **ENECRETE DuraQuartz** was used to fill in any imperfections to provide a smooth surface to the base.

**ENESEAL CR** was then applied to prevent corrosion where the steel meets the base as well as to give a clean, uniform look to the structure.

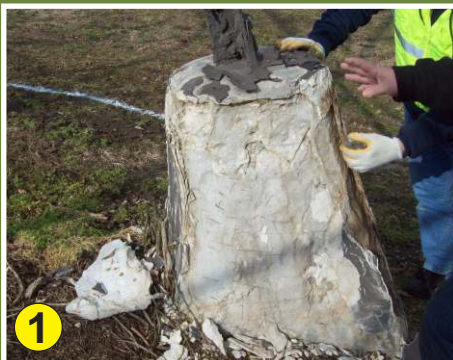
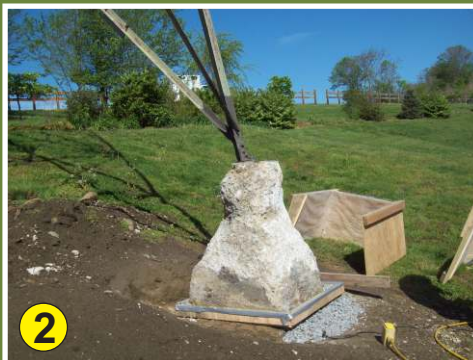
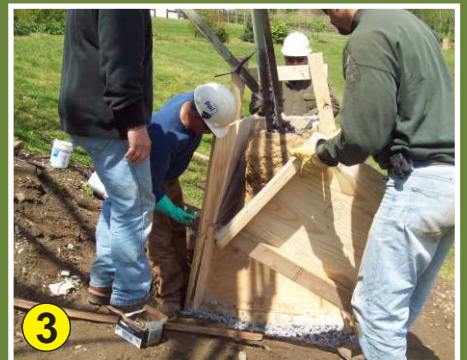
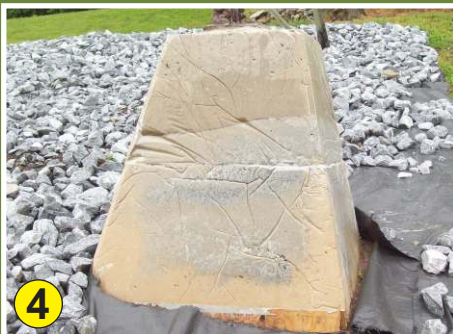
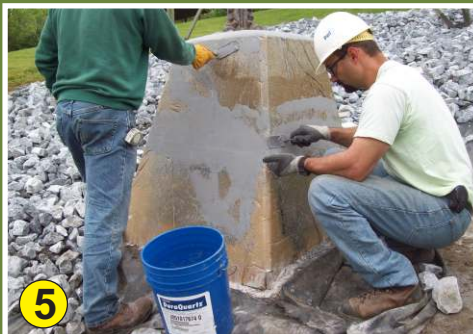
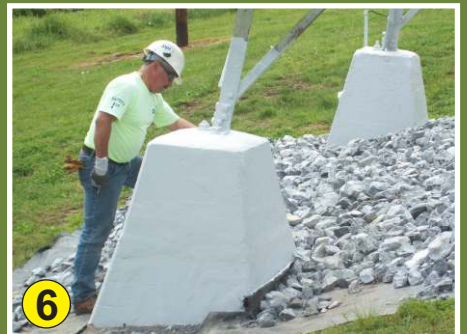
**Problem:** 2 Power transformers were involved in an accidental fire causing them both to have to be removed and eventually replaced. The onsite engineers were concerned about the integrity of the concrete bases the 37 ton transformers were mounted on. Cracks and damage were visible after the transformers were removed.

**Solution:** Loose concrete was removed from the bases as the area was manually prepared. Wood forms were

built around the bases and ENECRETE DuraFill, mixed with a locally sourced aggregate, was used to repair all the damaged areas. ENESEAL CR was then applied to give the bases a uniform look as well as protect them from future environmental exposure.

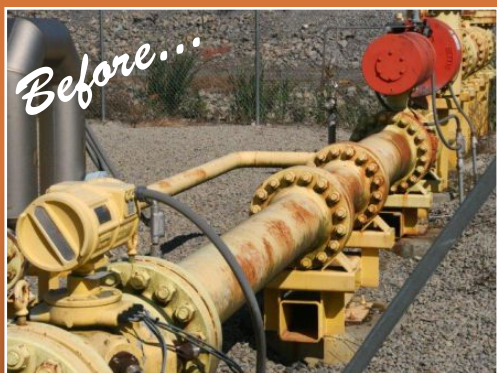
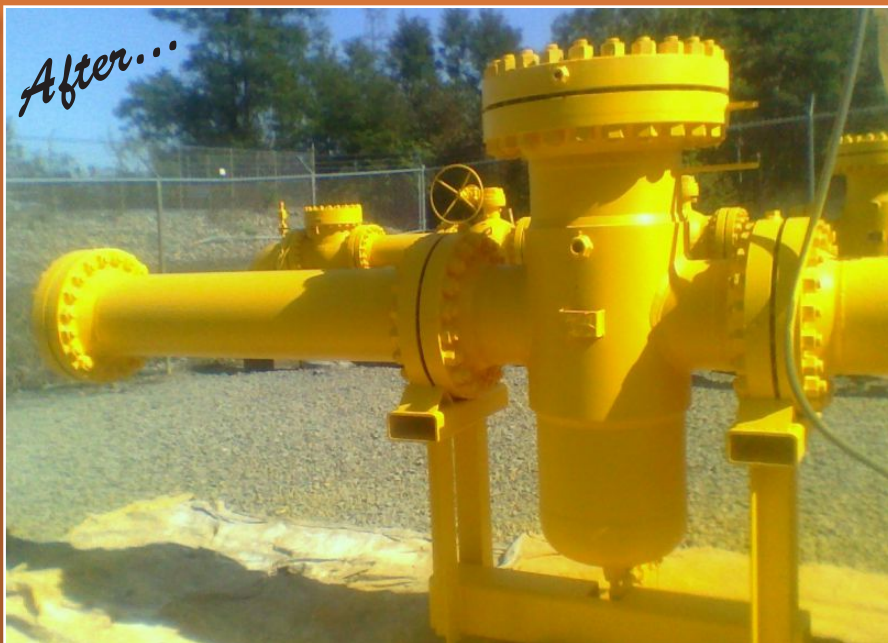
**Problem:** 600 linear feet of an 18 inch diameter gas line was suffering from corrosion. The power plant was looking for a protective coating that could be applied with only manual surface preparation.

**Solution:** High pressure power wash to remove failed coating and loose corrosion deposits. Application of a three coat system of ENESEAL CR Safety Yellow.

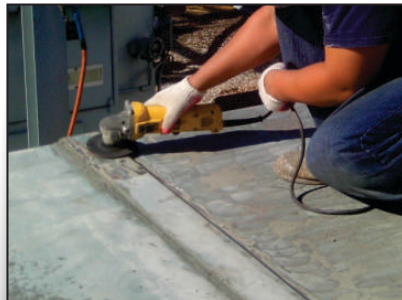
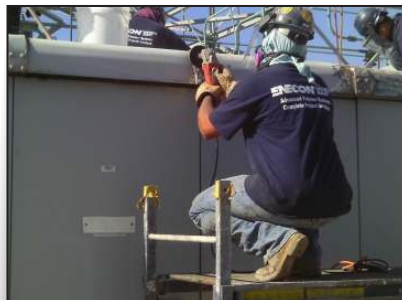
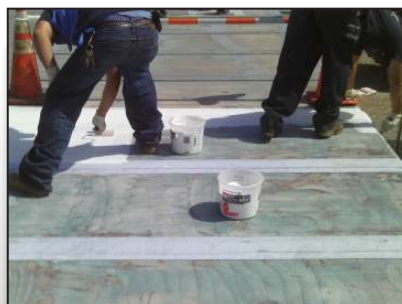
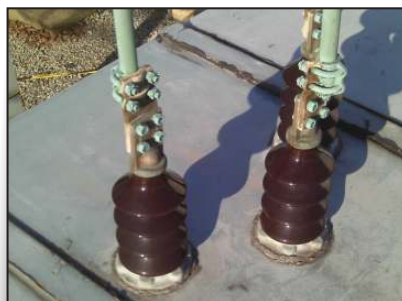
**Problem:** Aging switchgear cabinet roofs (constructed of galvanized sheet metal) were leaking at the seams and porcelain bushing penetrations.

**Solution:** After first removing the failing metal straps and rubber gaskets/seam covers, the entire roof was manually abraded. New 'coatable' roofing seam tape was applied to the open seams. ENESEAL CR was then applied as a 'primer' followed by two coats of ENESEAL HR.

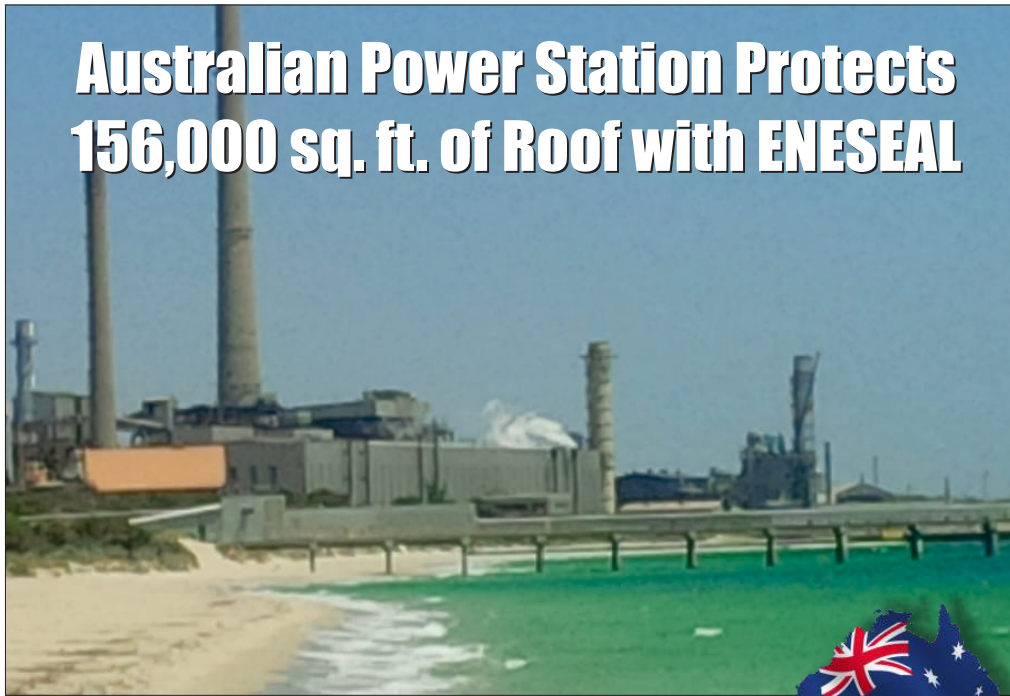
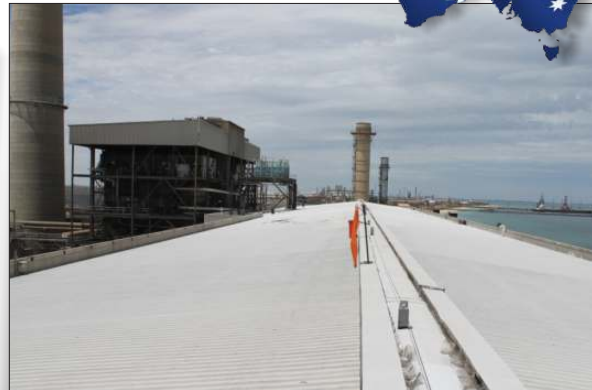
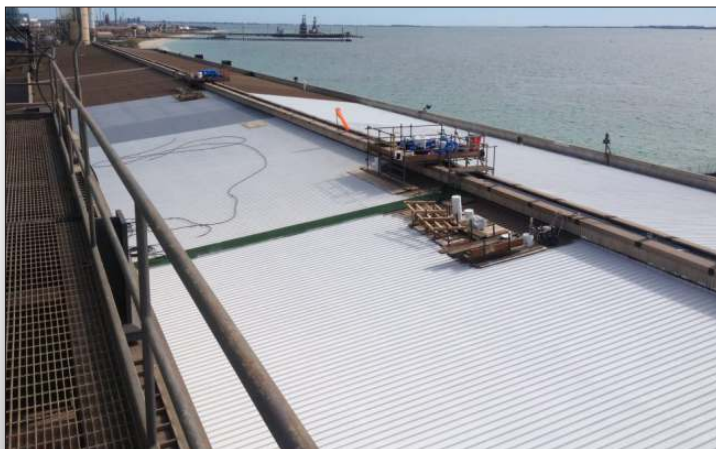
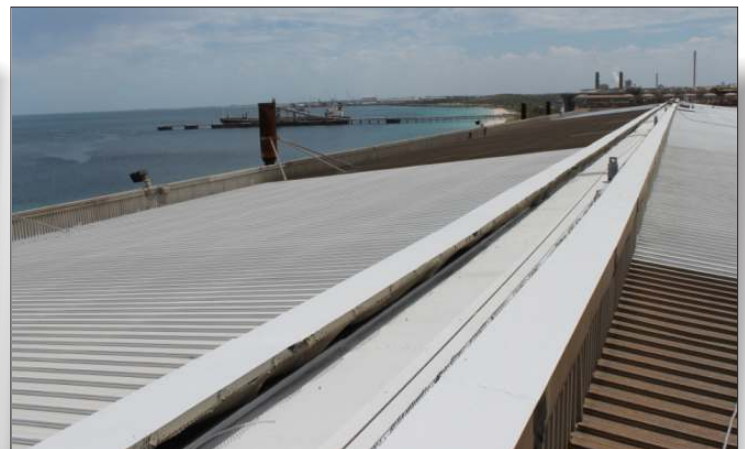
This 156,000 sq. ft. power station roof in Australia was in need of protection from the elements as well as airborne residue from an aluminum refinery nearby. ENECON Australia was called in to provide a solution.

After high pressure water blasting the entire roof, 345 units of ENESEAL CR were used to prime and seal the roof. Then 435 units of ENESEAL HR were used to provide a durable, seamless, flexible 'skin' that refracts and reflects heat while providing a moisture barrier to the roof.

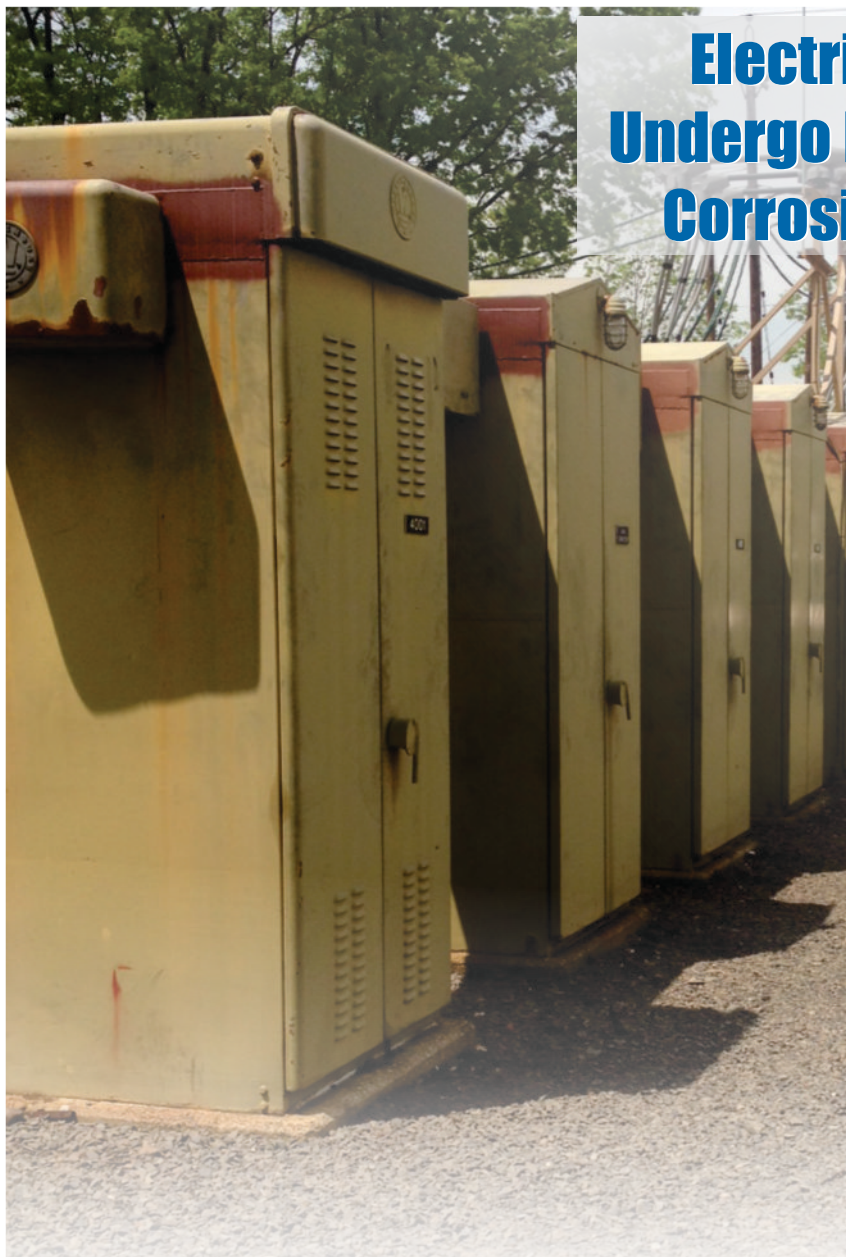
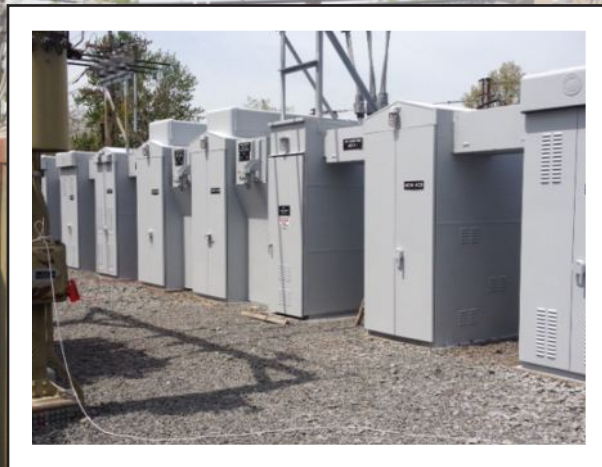
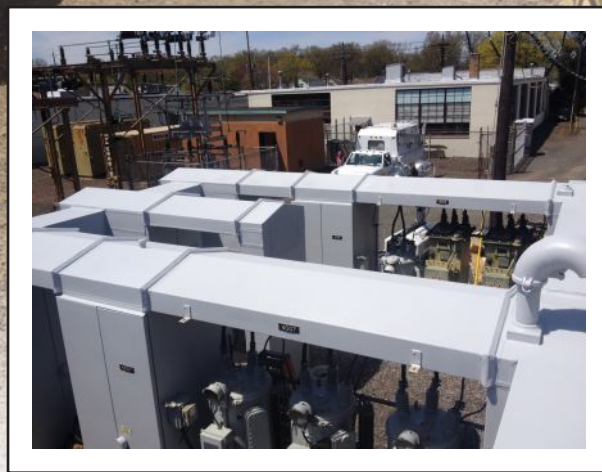
Many of these cabinets are 70-80 years old and leaks can cause the electrical equipment inside to explode, leading to power outages that can last months.

The ability to provide a detailed procedure for cabinet water-proofing and corrosion protection made ENECON the obvious choice for the power company's engineers.

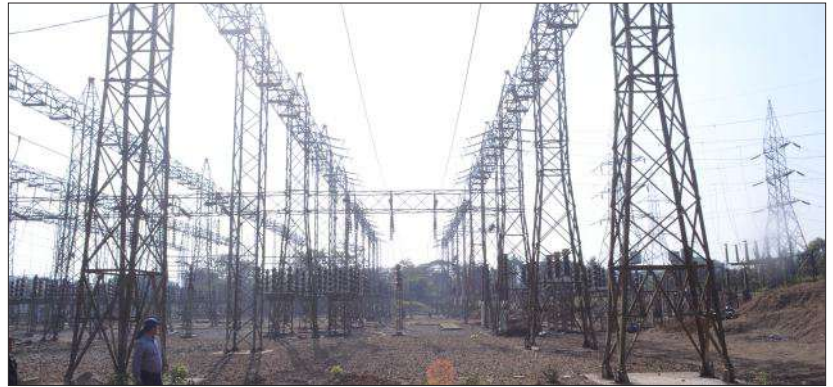
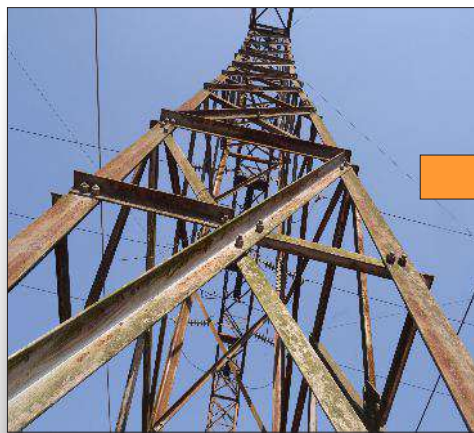
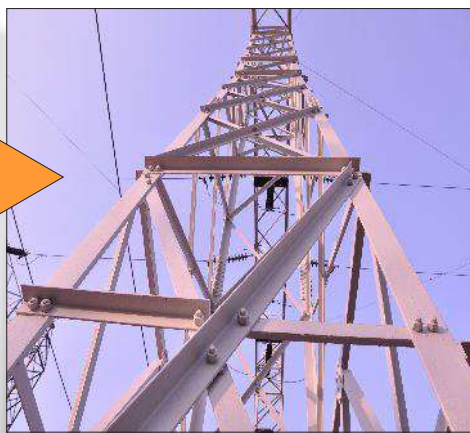
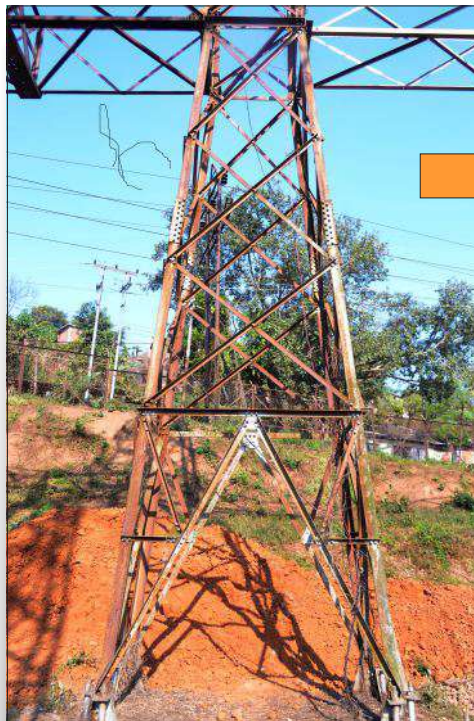
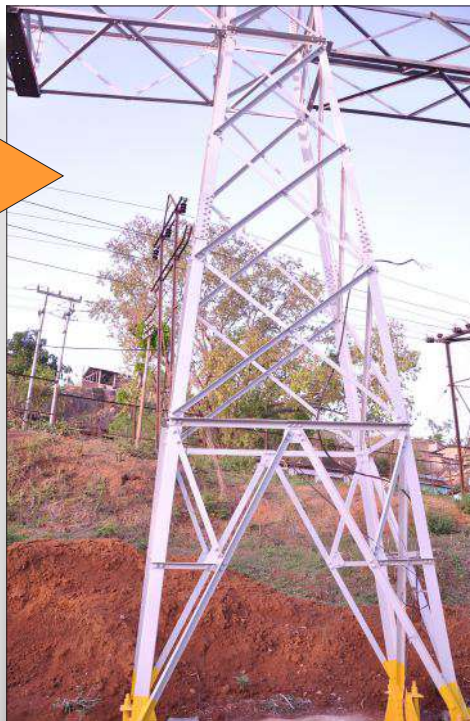
Built in the 1960's, these steel electrical towers were severely corroding because of the very humid and rainy weather in this region of India. The power company was looking for a cost effective solution to this on-going problem.

ENECON's ENESEAL CR was first used for a variety of sample tests throughout the substation and after a 6 month trial period, ENESEAL CR was approved and specified for this application.

Over 12,000 sq. ft. of surface area was coated with ENESEAL CR. The power company engineers were so pleased with the results, additional substation towers will now be coated and protected.

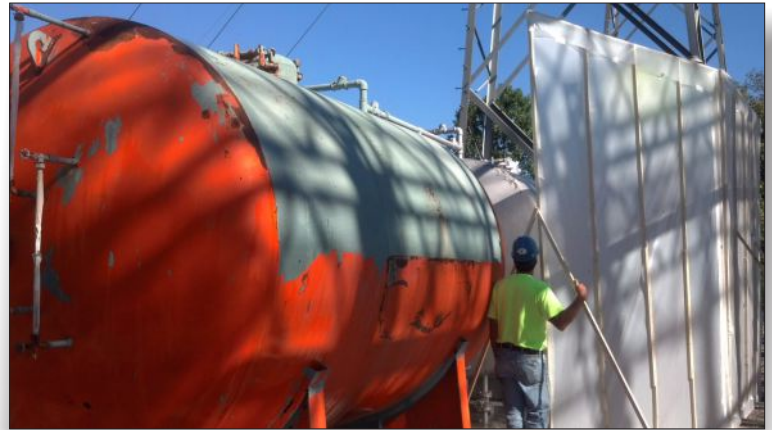
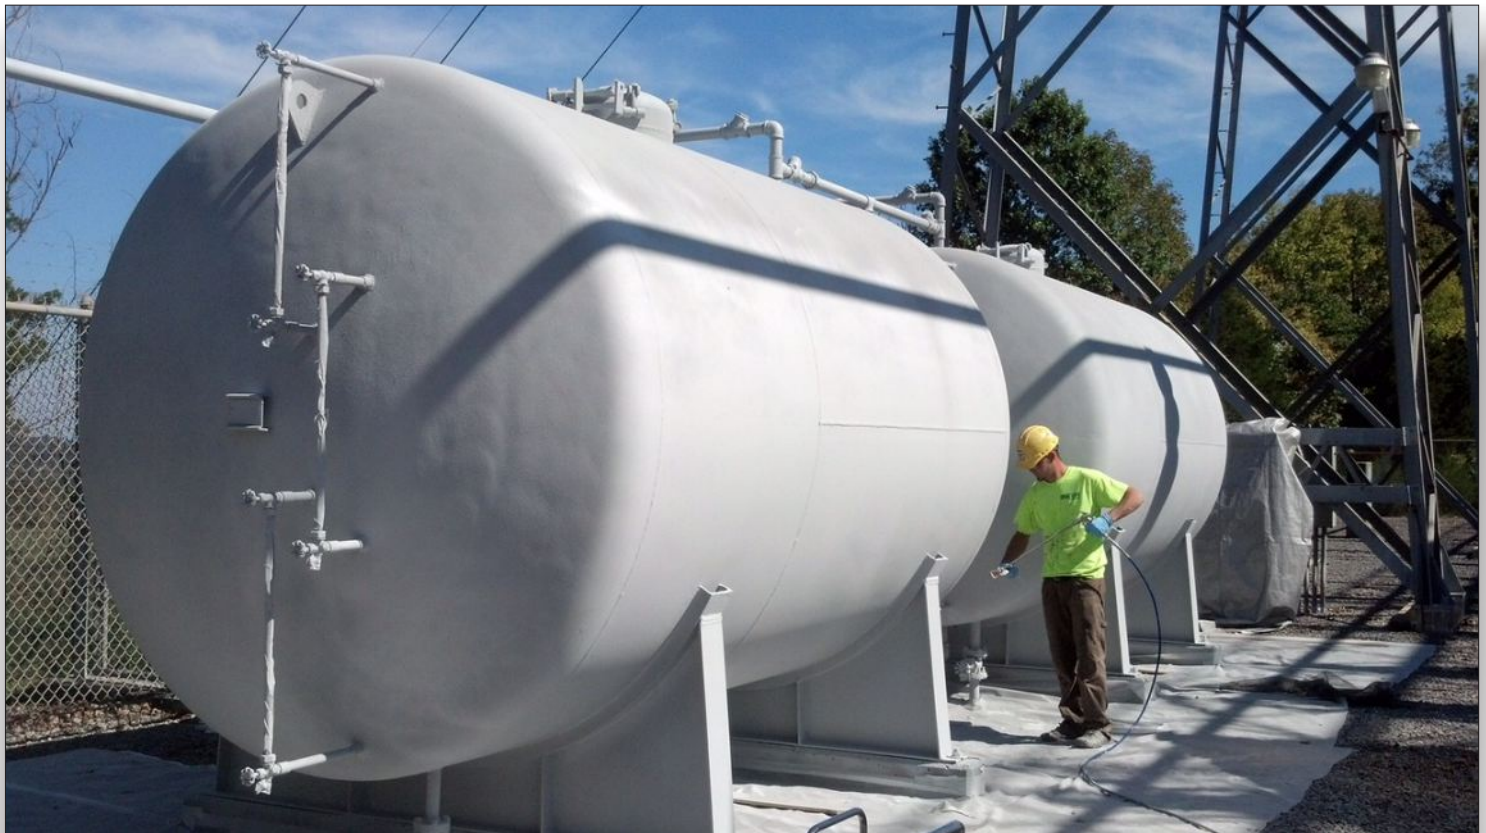
These large oil storage tanks located at a hydroelectric facility in Tennessee were in need of a new protective coating. The old lead-based paint was beginning to peel and surface corrosion was visible in certain areas.

containment was constructed prior to the tanks' surface preparation. The old lead-based paint was removed by pressure washing and then properly disposed of.

Two coats of ENESEAL CR were then applied providing a highly durable, corrosion resistant, elastomeric 'skin'.

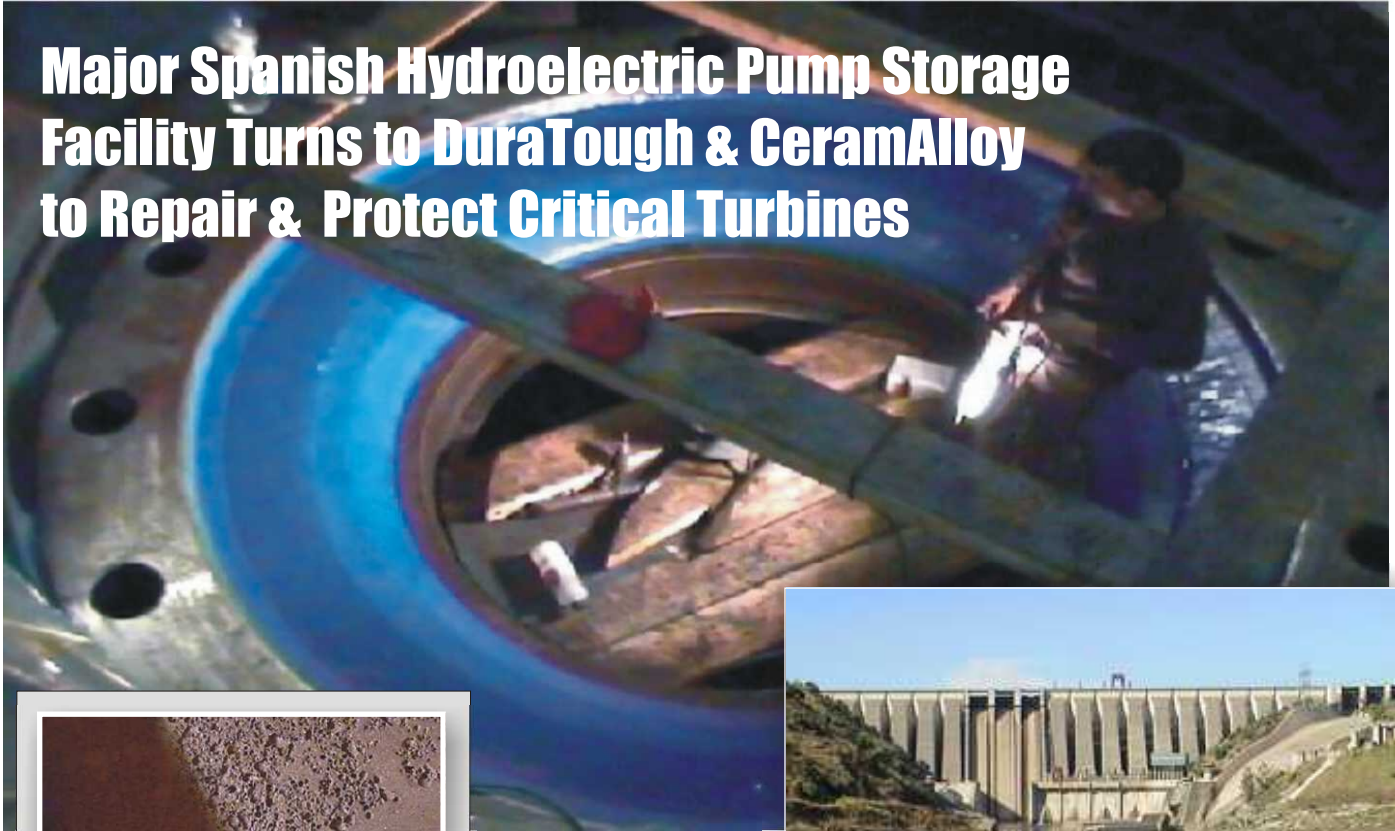
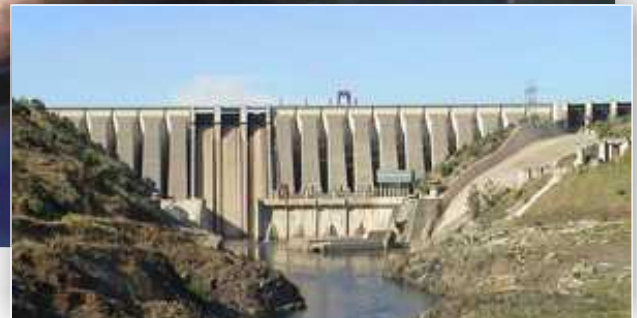
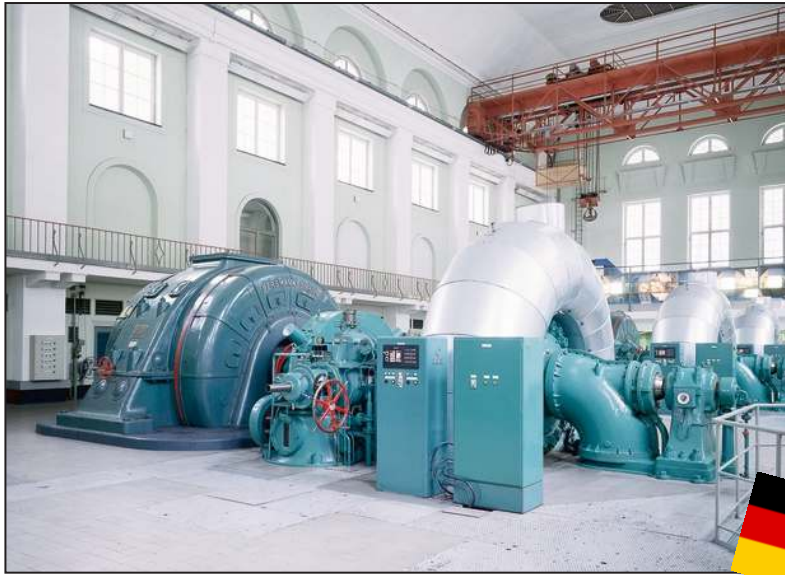
At this hydroelectric plant - one of the most important facilities in Spain - erosion and corrosion damage had created a serious maintenance concern for the plant engineers. They needed a cost effective and commercially proven solution to their cavitation accelerated, erosion/corrosion problems. They turned to their local ENECON Ibérica

Field Engineering Team who recommended CeramAlloy to repair and protect all areas subject to erosion and corrosion with an added application of DuraTough on those areas subject to cavitation attack.

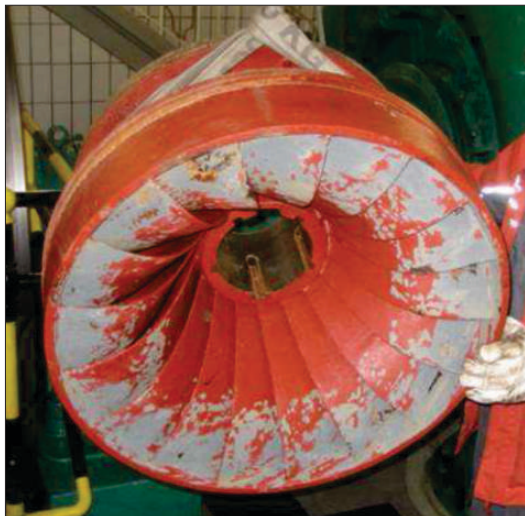
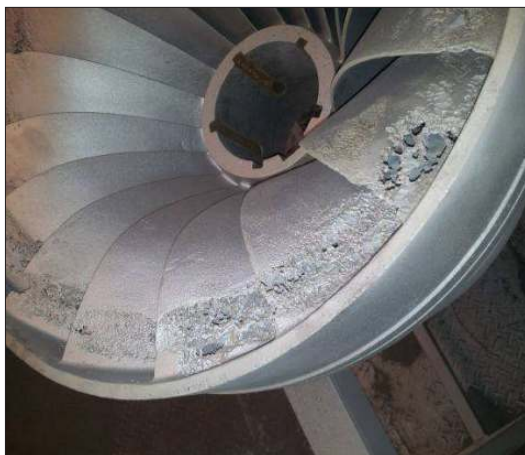
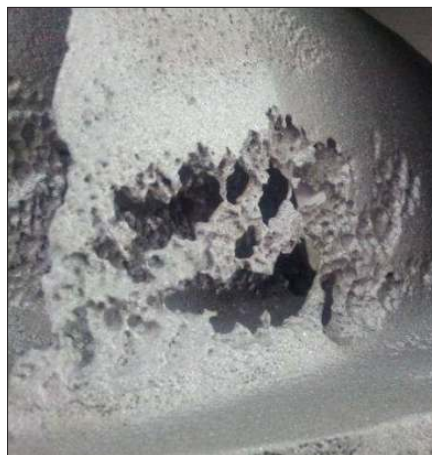
**Problem:** Francis turbine vanes were suffering from erosion and corrosion due to the effects of cavitation after the failure of a previously applied coating.

**After operating for 7,000 hours, the repaired turbine was opened for an inspection and found to be in near perfect condition.**

**Solution:** After grit blasting the turbine, the vanes were rebuilt by tack welding steel mesh to the deeply cavitated areas. The vanes were then rebuilt with CeramAlloy CP+AC then two coats of CeramAlloy CL+AC were applied. DuraTough DL was applied to protect against future cavitation problems.

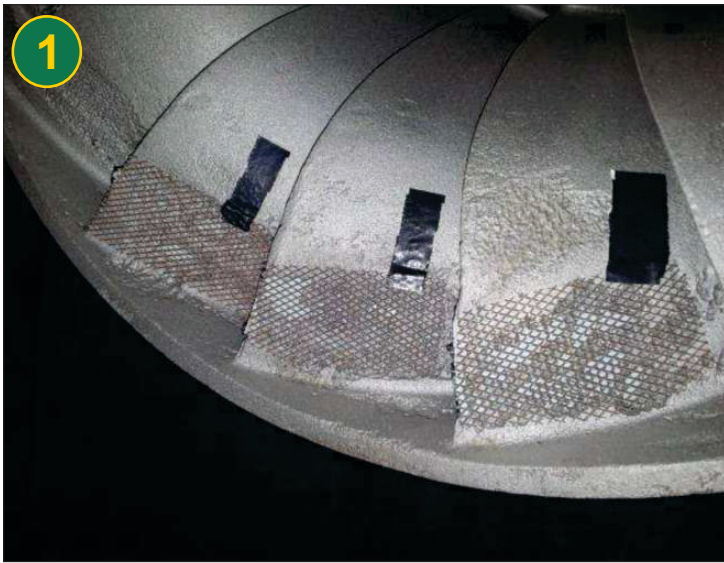
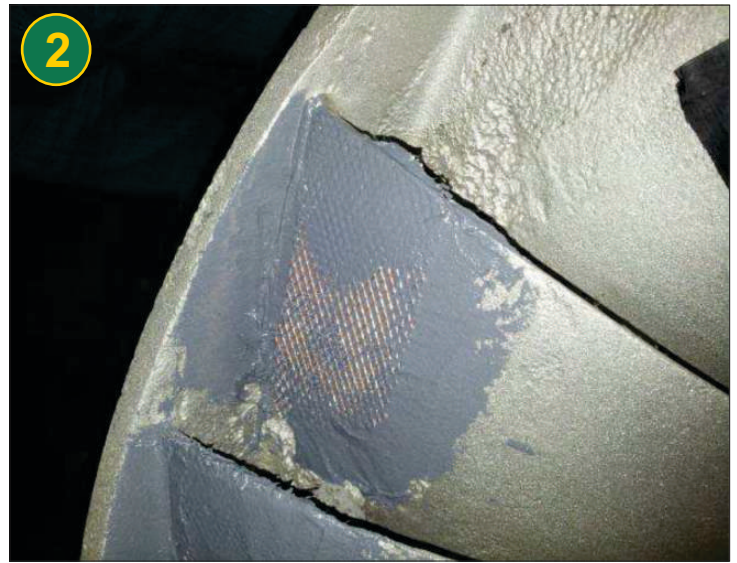
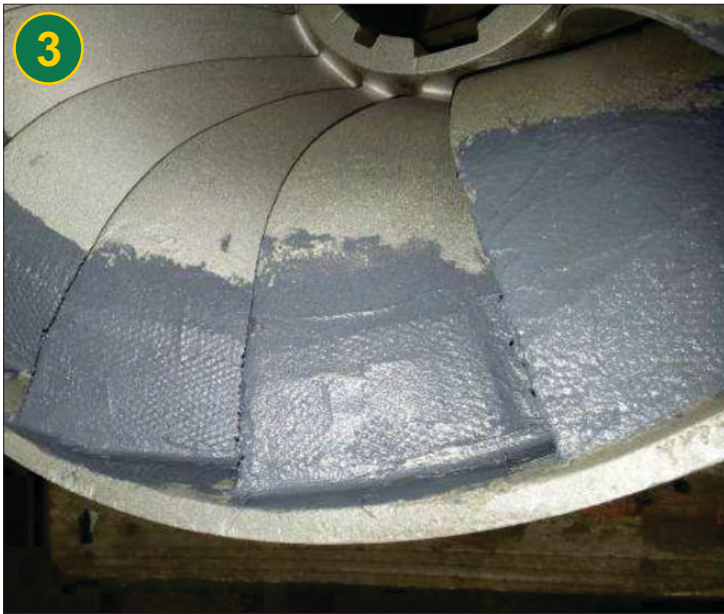
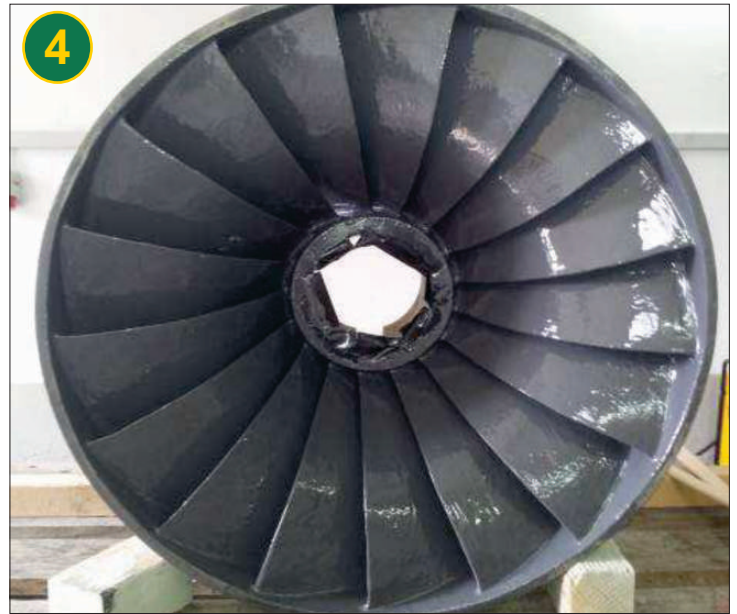
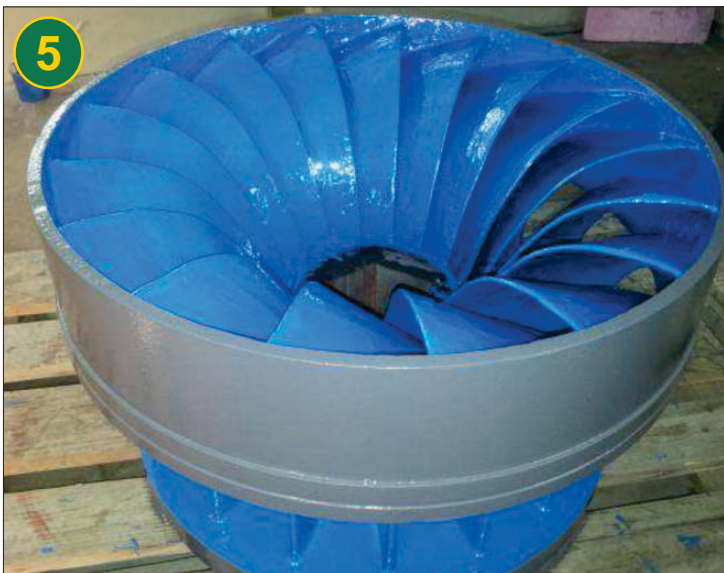
- 1. Steel mesh is welded to the vanes.**
- 2. CeramAlloy CP+AC covers the mesh repairs.**
- 3. CeramAlloy CP+AC rebuilds the vanes.**
- 4. The turbine is coated with CeramAlloy CL+AC.**
- 5. DuraTough DL provides the cavitation protection.**

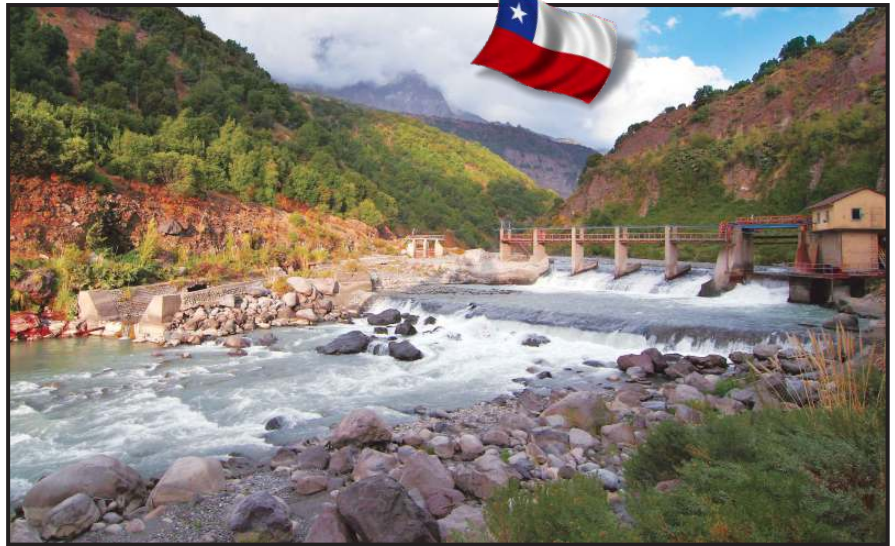
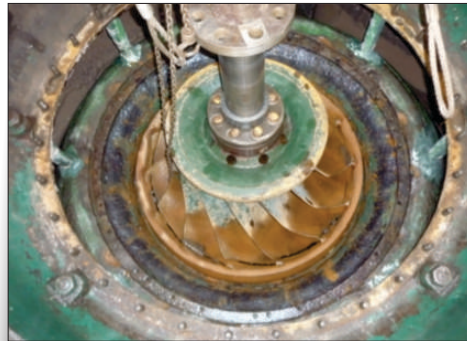
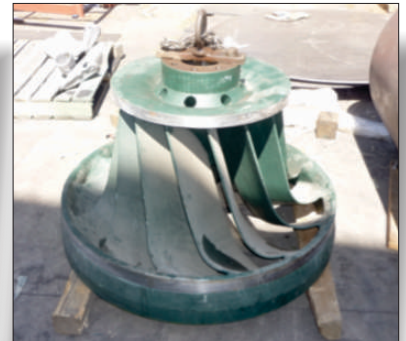
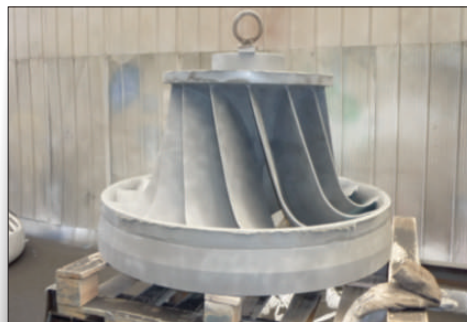
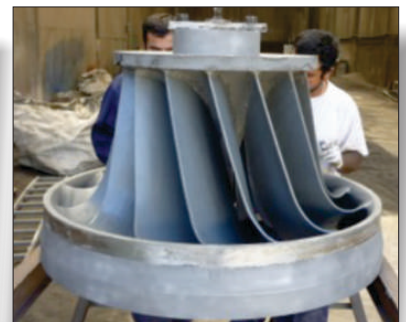
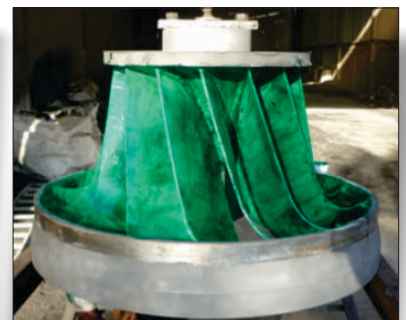
*In a 54-year old hydroelectric plant near Santiago, Chile, major problems of erosion, corrosion and cavitation, made even more severe by a large amount of suspended solids, necessitated a complete refurbishment of this Francis turbine.*

*After cleaning and grit-blasting the turbine, METALCLAD CeramAlloy CP+AC was applied to rebuild all deeply eroded areas. CeramAlloy CL+AC was then used to resurface the turbine blades. Finally, the FLEXICLAD DuraTough DL system was used to protect all wet areas against cavitation as well as the abrasive action of the sand and silt in the river water.*

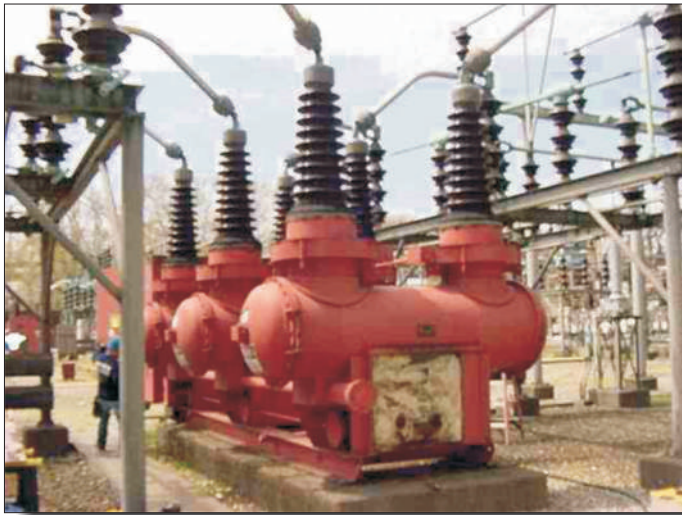
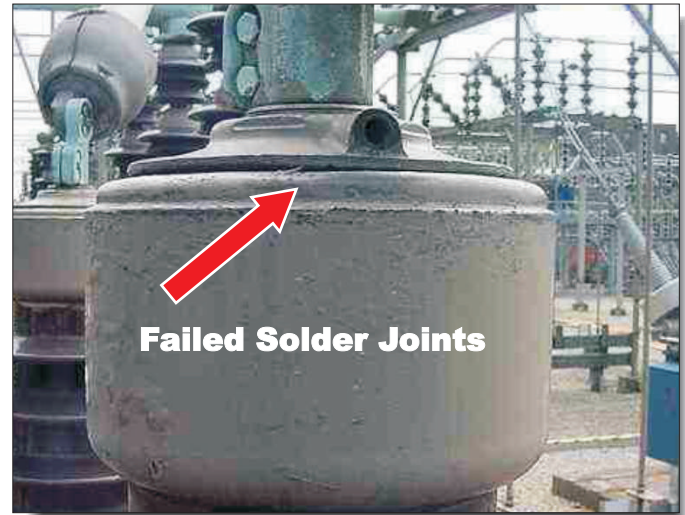
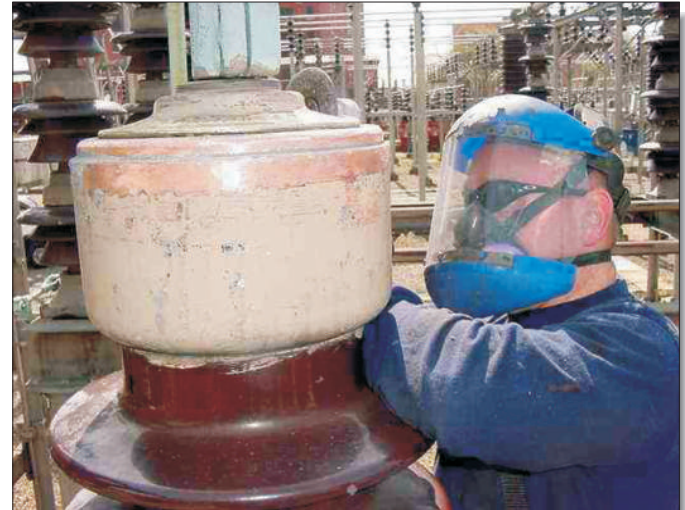
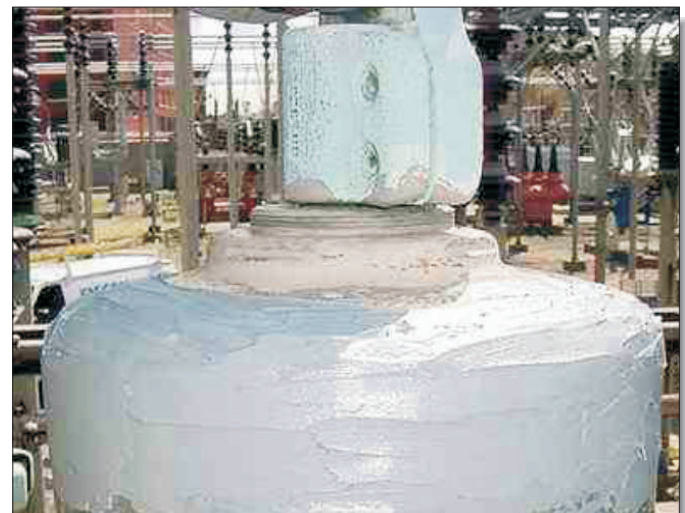
A major Northeastern U.S. utility company was experiencing SF-6 gas leaks on its substation breakers. Cracks in the old solder joints were causing this gas to leak from the insulator bushing caps. SF-6 gas has excellent cooling and insulation capabilities. However, SF-6 gas is an expensive and ozone-depleting gas so leaks are unacceptable.

First, the old solder and paint were stripped away from the bushing caps. After a thorough cleaning, DurAlloy was applied to completely seal the failed joints.
