## Power Plant in Thailand Uses CeramAlloy and CHEMCLAD to Repair and Protect Cooling Water Pipeline

## ENECRETE, ENECLAD & CHEMCLAD Repair & Protect Containment Areas at Chilean Power Plant

## CHEMCLAD GP Continues to Fight Corrosion on Waste Removal Trailers

## Geothermal Energy Plant Rebuilds and Protects Acid Containment Area with ENECRETE & CHEMCLAD

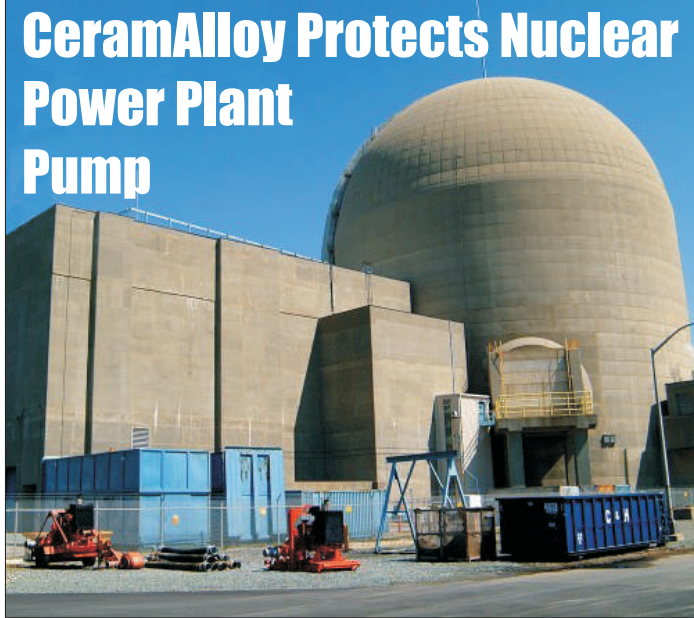
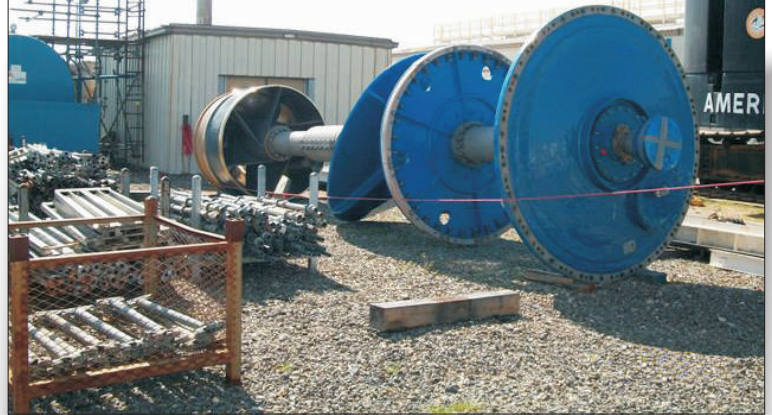
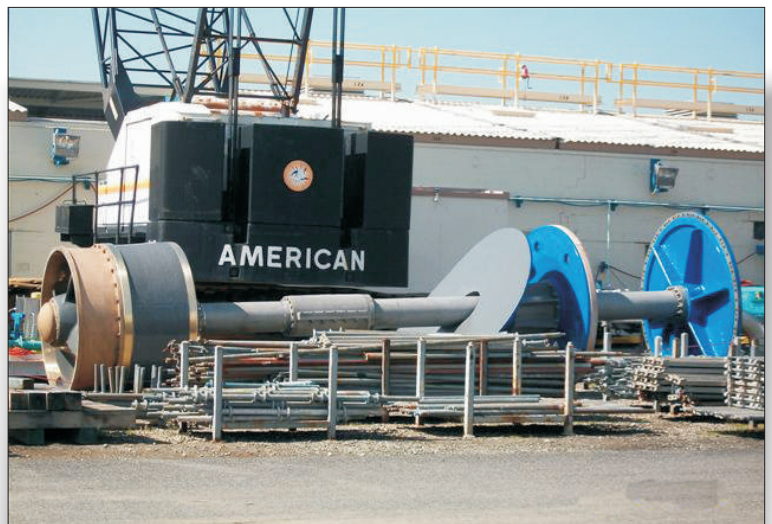
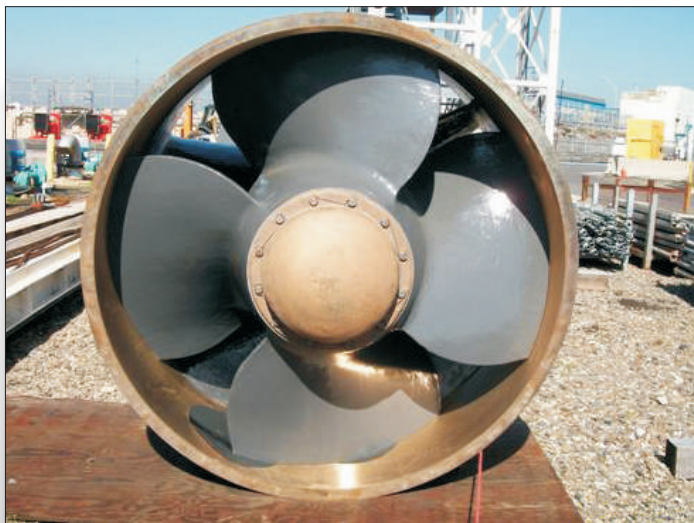
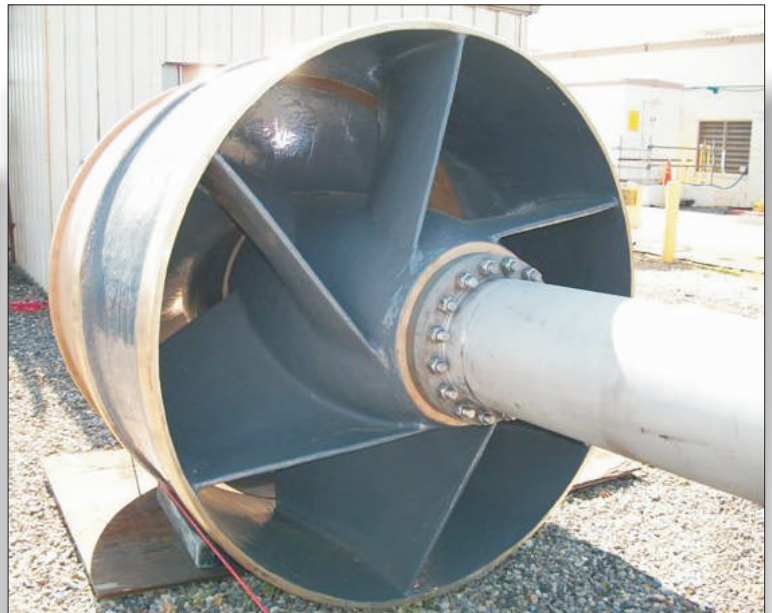
Over 3 years ago this large main circulating pump, 1 of 12 at this Mid-Atlantic region nuclear power plant, had been coated with 3 coats of CeramAlloy™ CL+AC.

During a scheduled maintenance shut-down the plant engineers discovered that the CeramAlloy™ CL+AC was in virtually perfect condition.

Following minor touch-ups, the pump was put back in service for another 3-year cycle.

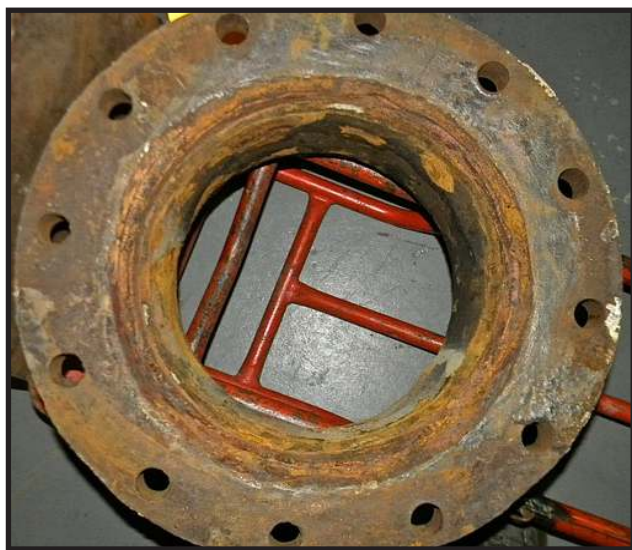
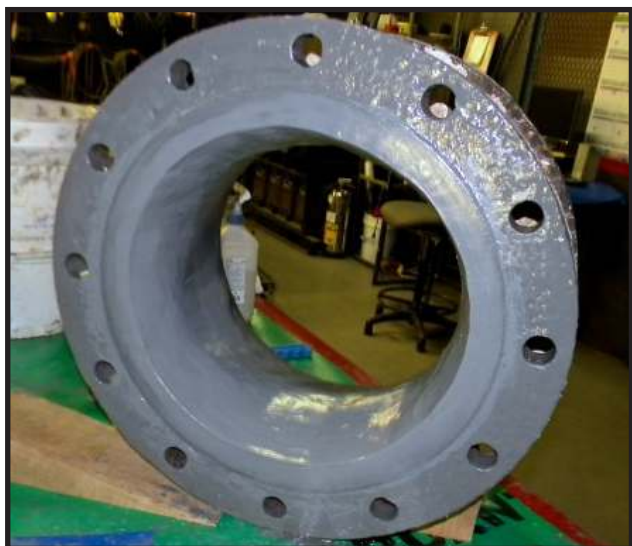
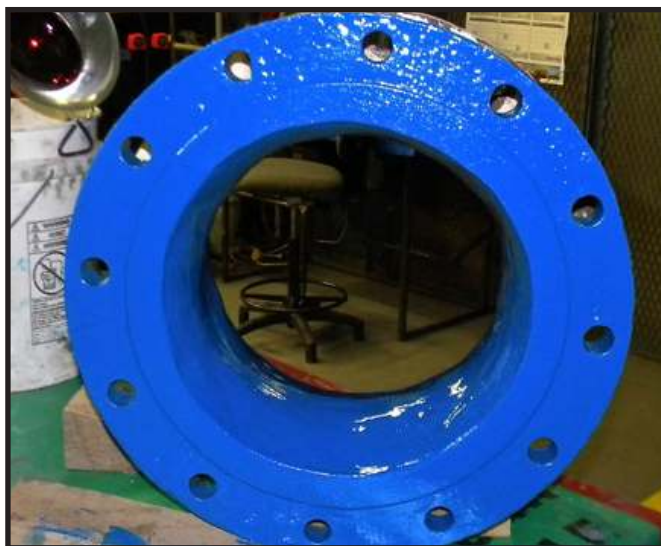
The component is a 14” diameter, cement lined, spool piece that is mounted between a large strainer and an isolation valve on the service water system at a nuclear power station. During a refueling outage, this spool piece was removed to allow for maintenance on an adjacent component. The deteriorated condition of the piece was unexpected. The cement lining was severely eroded as were the inside diameters of both the inlet and outlet flanges.

The onsite ENECON Northeast service team, was asked to accomplish abrasive blasting of the component so that plant engineers could make an assessment of the true condition. Once the spool piece was determined to be structurally sound, **METALCLAD CeramAlloy CP+** was used to rebuild the spool lining and damaged flanges and **METALCLAD CeramAlloy CL+** was used to totally encapsulate the surfaces exposed to the brackish river water.

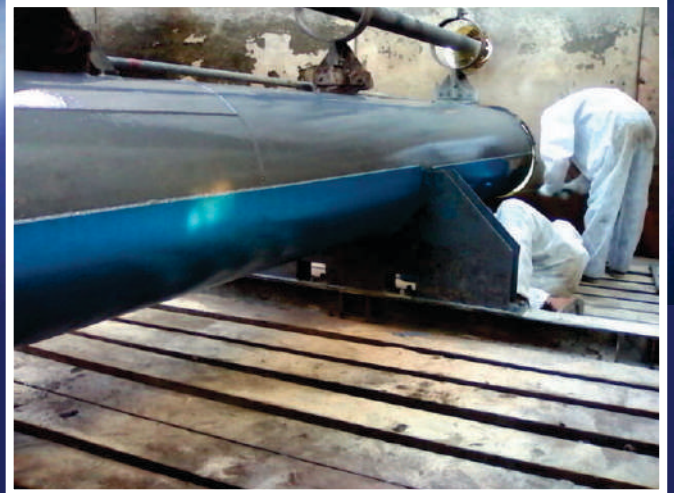
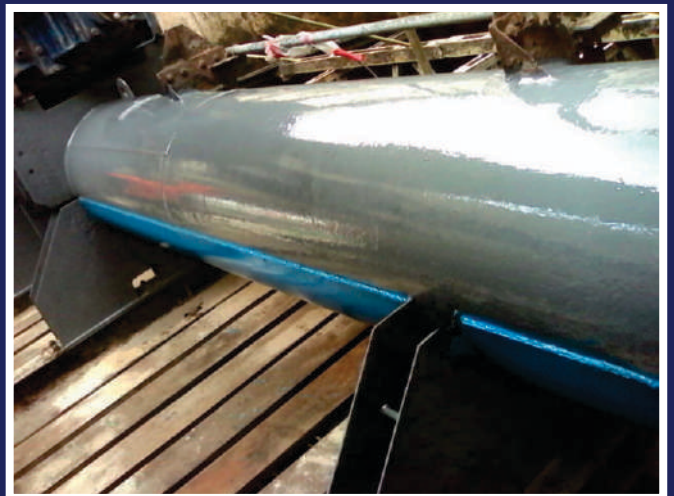
*This cooling water pipeline at a power plant in northern Thailand is subject to severe erosion and corrosion due to water forced out by the fans located on top of the pipes as seen in the bottom left photograph.*

*The bottom half of the pipe (only 2 mm / .08 inches thick in some areas) was repaired using welded plates which were bonded to the pipe with CeramAlloy CP+AC followed by two layers of CeramAlloy CL+AC.*

*The top of the pipe was coated with CHEMCLAD GP as a cost saving measure.*

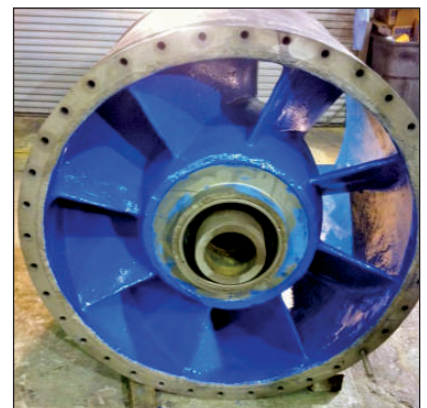
The completed component ready for service.

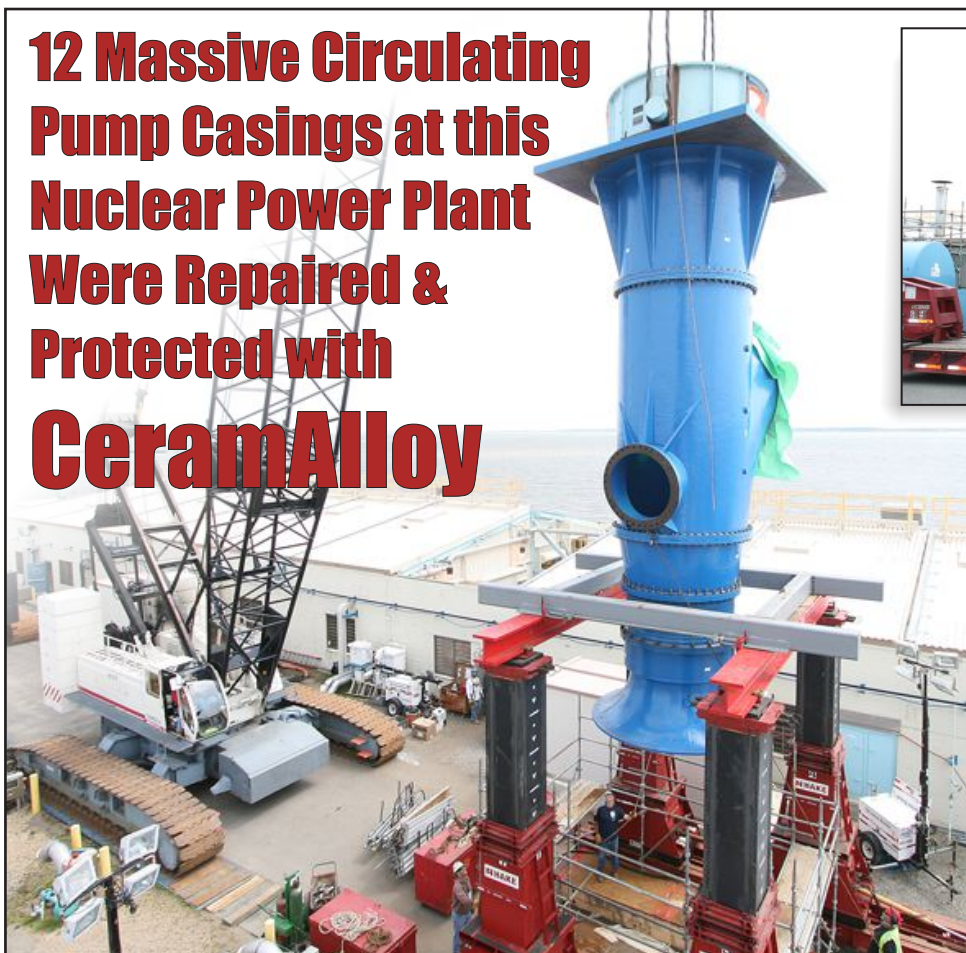
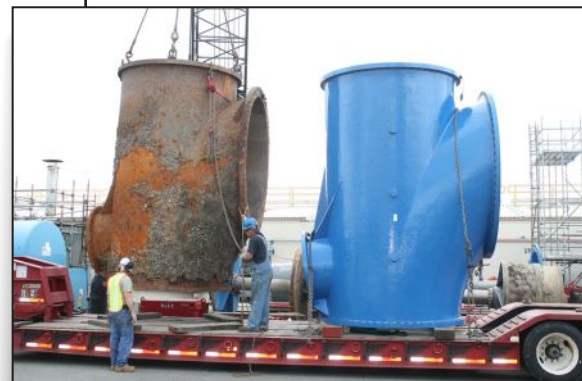
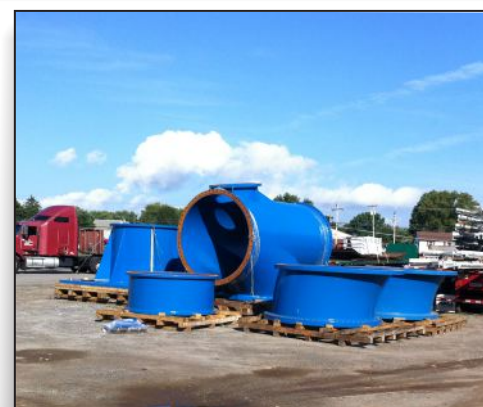
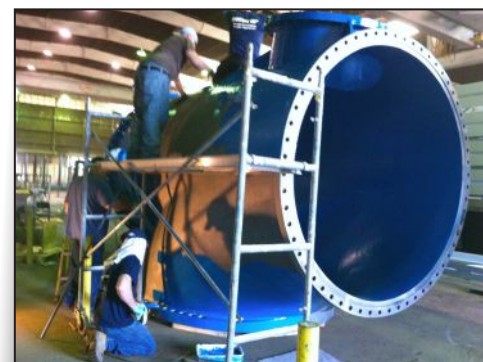
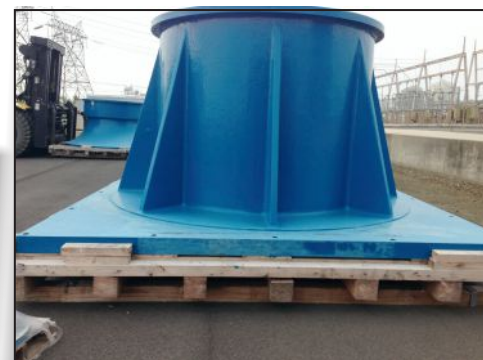
A major U.S. nuclear power plant chose ENECON to supply turn-key services to install CeramAlloy CL+AC on 12 massive circulating pump (circ. pump) casings. The plant's engineers felt that the performance of CeramAlloy on the circ. pump impellers, (reference MT-114) in a demanding brackish water environment was proof enough that CeramAlloy should be used to protect 12 circ. pump casings during a system overhaul.

The circ. pump components were shipped directly to ENECON at a local blasting facility large enough to stage and blast all of the components. Once the interior and exterior surfaces were abrasive blasted, the ENECON application team applied 3 coats of CeramAlloy CL+AC to all interior and exterior surfaces.
